Inspection Report

Sample Report

Property Address:
5741 Sample Property Drive
Washington UT 84780

Blue Majestic Home Inspections LLC

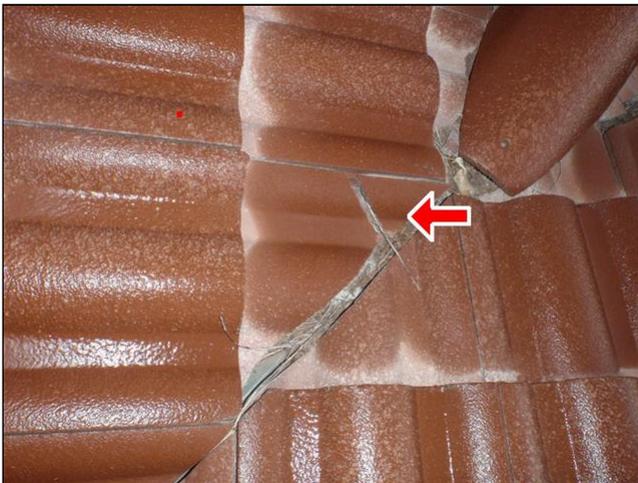
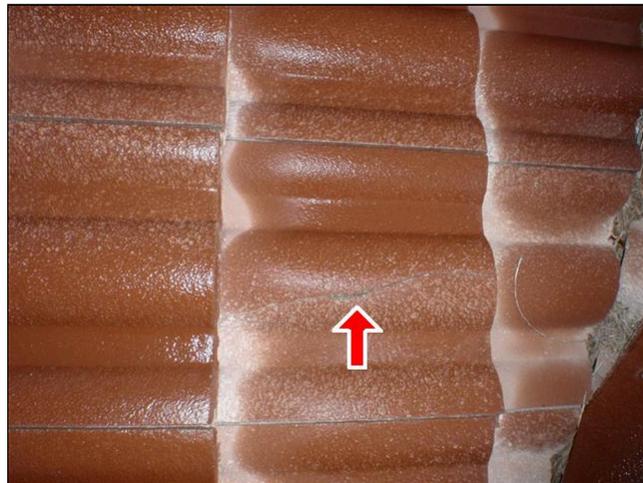
1.0 (1) Broken concrete roofing tiles at various areas. Recommend replace broken tiles by a licensed roofing contractor.

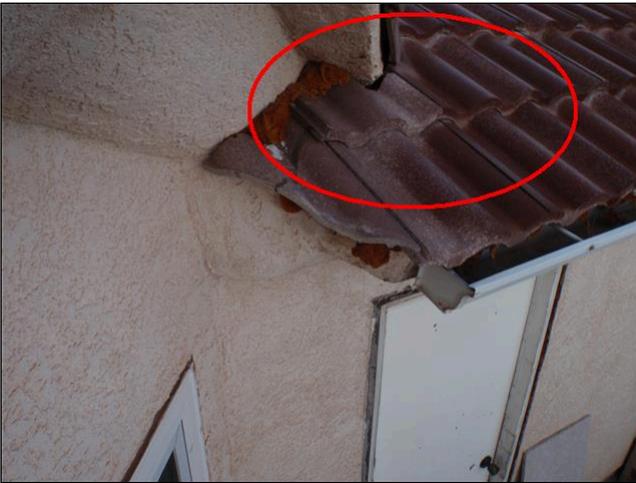
1.0 Item 8(Picture)

(3) Roof covering leak observed in the area above the garage outside occupant door, wet roof sheeting and drywall. Recommend repair, replace or correct by a licensed roofing contractor.

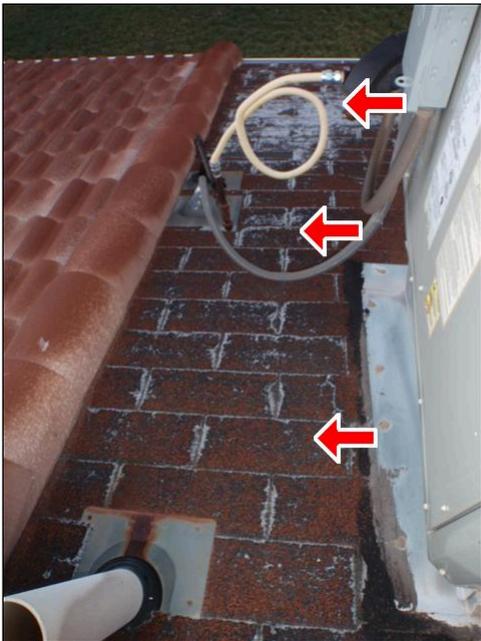
1.0 Item 14(Picture)

(4) Three tab fiberglass shingle roof covering at HVAC unit area are old and have major granular loss. The covering needs replaced. Recommend repair, replace or correct by a licensed roofing contractor.

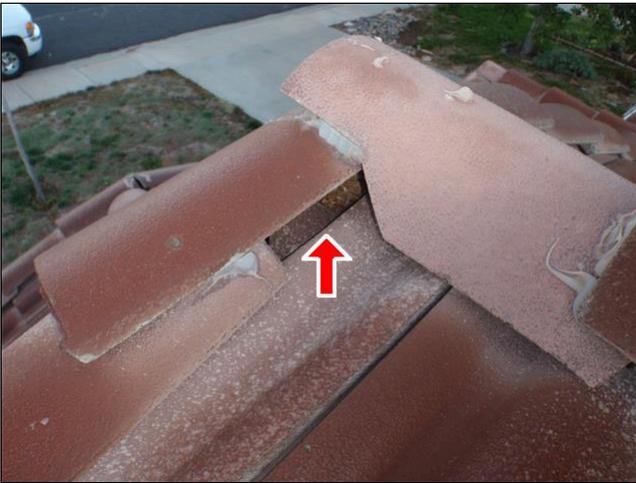
1.0 Item 18(Picture)

(5) Opening in tiles where concrete hip cap tile meets concrete ridge cap tile exposing underlayment and bare wood. Recommend seal with mastic by a licensed roofing contractor to prevent water intrusion.

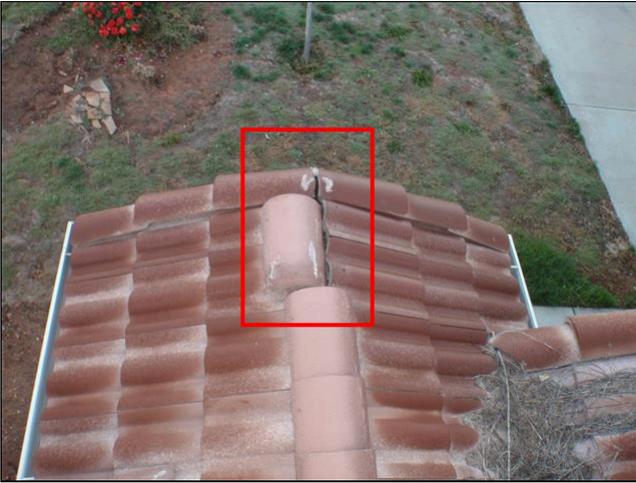
1.0 Item 19(Picture)

(6) Ridge cap tile missing. Recommend replace or correct by a licensed roofing contractor.

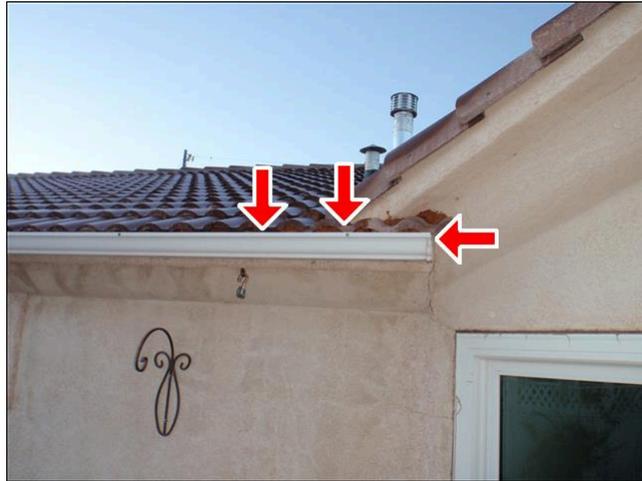
1.1 Item 2(Picture)

1.1 Drip edge flashing missing at the rear patio area and spray foam has been used. Recommend repair, replace or correct by a licensed roofing contractor.

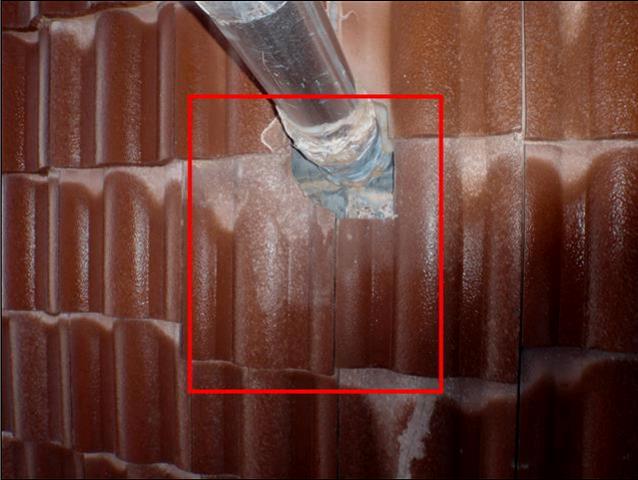
1.2 Item 1(Picture)

1.2 Water heater exhaust vent flashing not installed properly, underlayment damaged below concrete tiles. Recommend repair, replace or correct by a licensed roofing contractor.

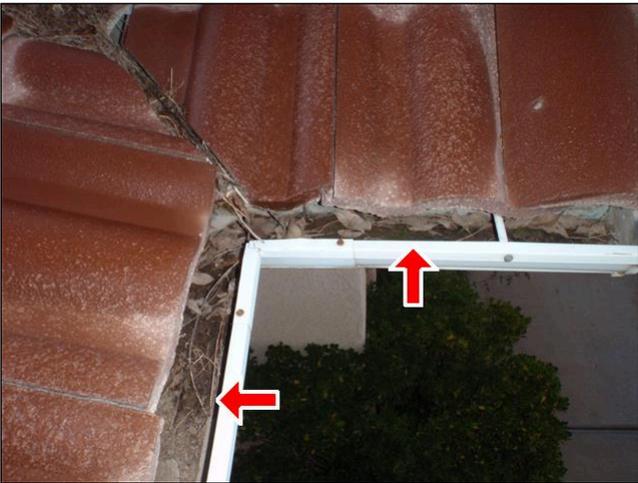
1.3 Item 1(Picture)

1.3 The rain gutters are full of debris in areas and need to be cleaned. Recommend cleaning rain gutters by a qualified person.

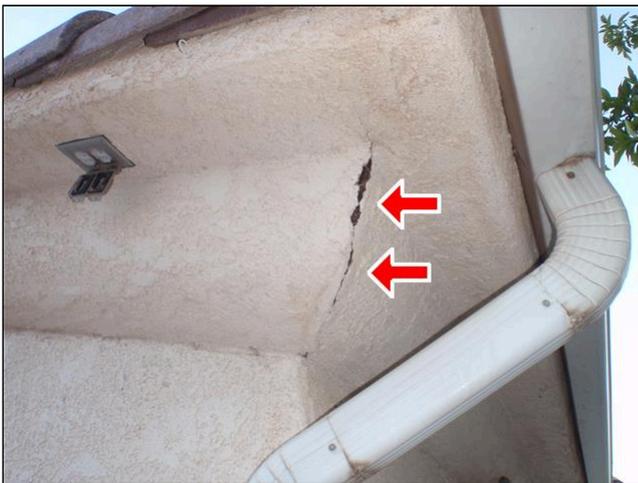
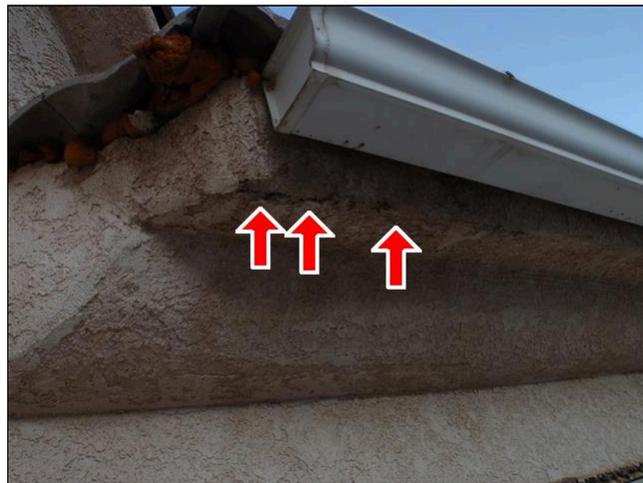
2.0 (1) Stucco damaged, (cracks and peeling as well as exposed lower styrofoam insulation around the whole house) appears to be from moisture. Recommend further evaluation by a licensed stucco contractor.

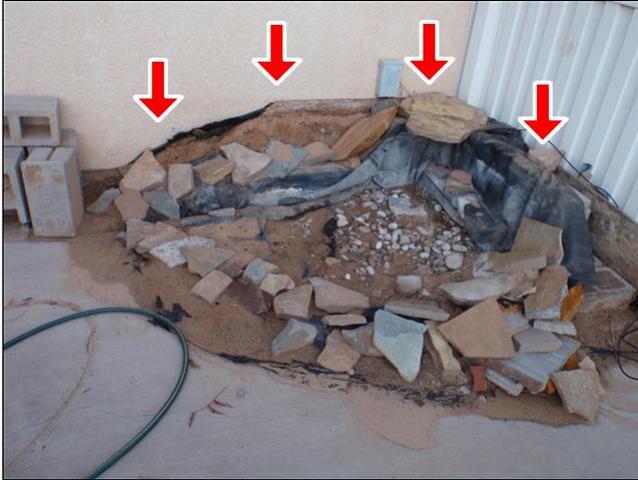
2.0 Item 14(Picture)

(2) Rear patio area, plastic and wood against the stucco is damaging the stucco siding (attracts wood rot and termites). Recommend repair or correct by a qualified person.

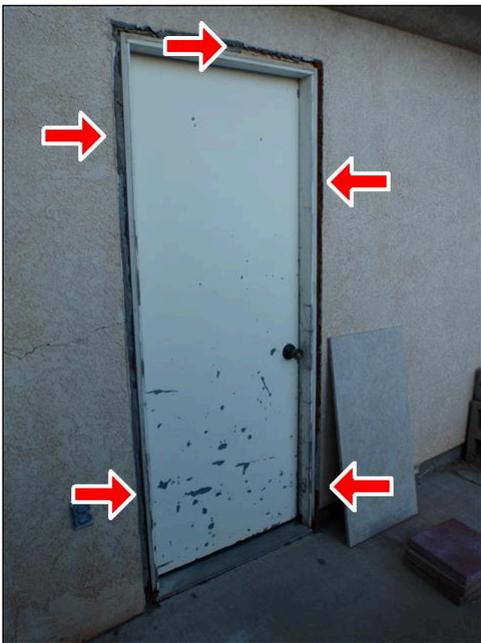
2.0 Item 15(Picture)

(3) Wood trim around garage outside occupant door is missing. Recommend repair, replace or correct by a qualified person.

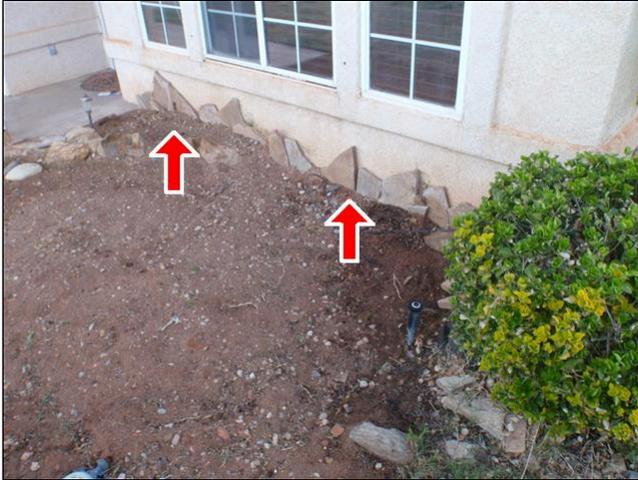
2.0 Item 16(Picture)

(4) Front area, soil and rock against the stucco is damaging the stucco siding (attracts wood rot and termites). Recommend repair or correct by a qualified person to prevent moisture and insect intrusion.

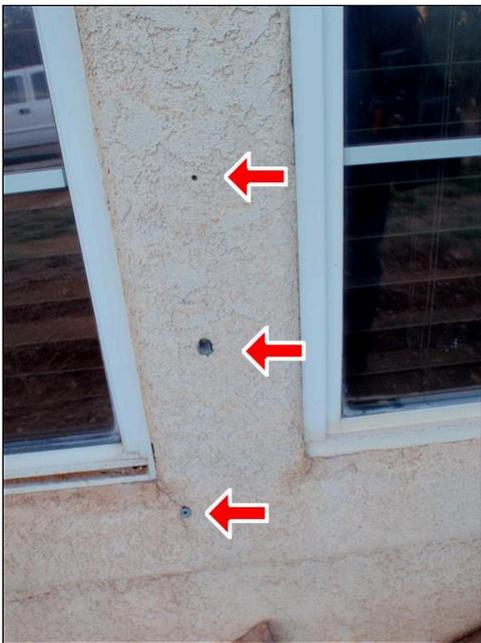
2.0 Item 17(Picture)

(5) Holes in stucco (front of home). Recommend seal holes with caulking by a qualified person to prevent moisture and insect intrusion.

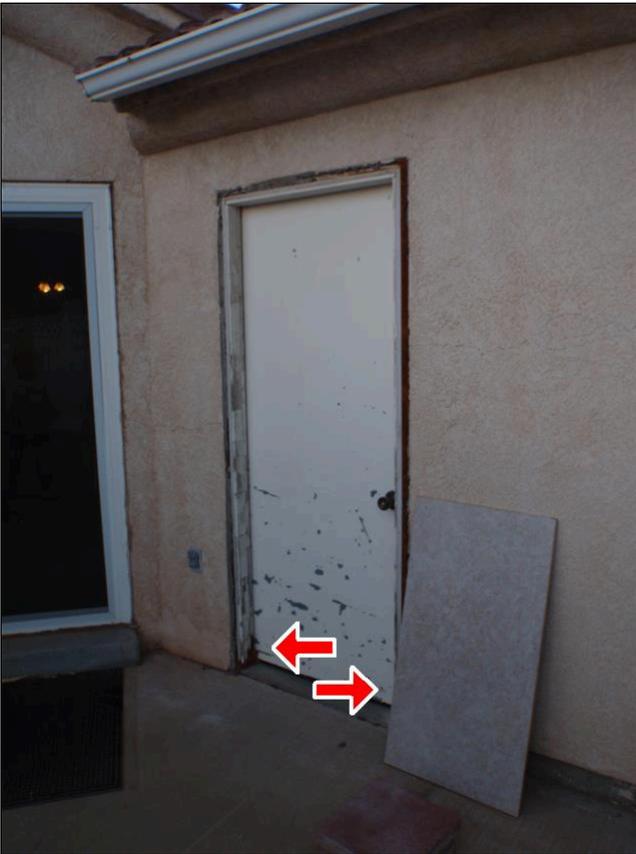
2.1 Item 1(Picture)

2.1 (1) Rear garage occupant door, wood rot at lower door jamb. Recommend repair, replace or correct by a licensed building contractor.

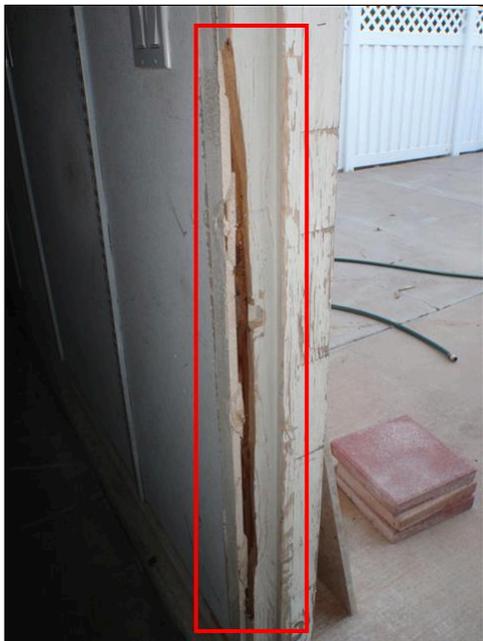
2.1 Item 4(Picture)

(2) Rear garage occupant door jamb damaged and missing striker plate, door will not stay secured and will not lock. Recommend repair, replace or correct by a licensed building contractor.

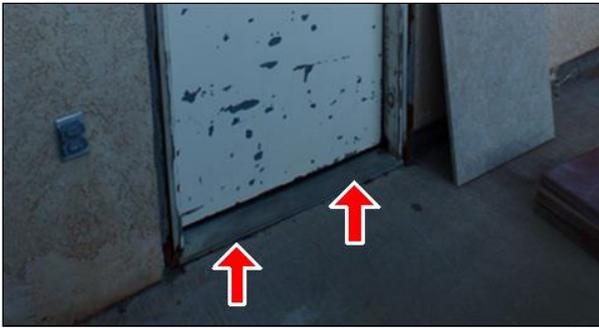
2.1 Item 5(Picture)

(3) Garage rear occupant door threshold appears to be loose. Recommend repair, replace or correct by a qualified person.

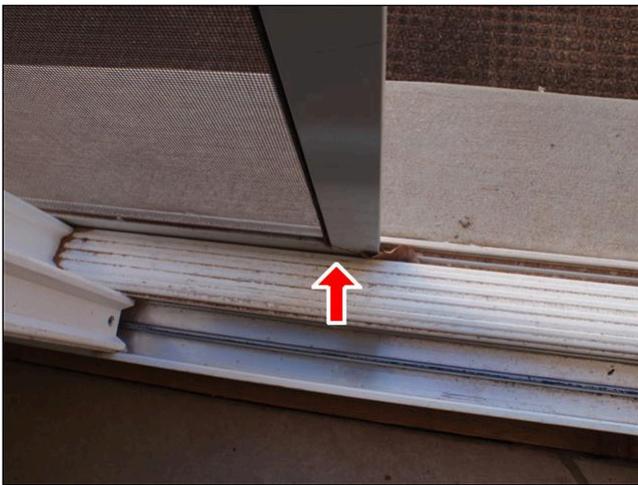
2.1 Item 6(Picture)

(4) Rear sliding screen door is very hard to slide open and close (rollers damaged). Recommend repair or correct by a qualified person.

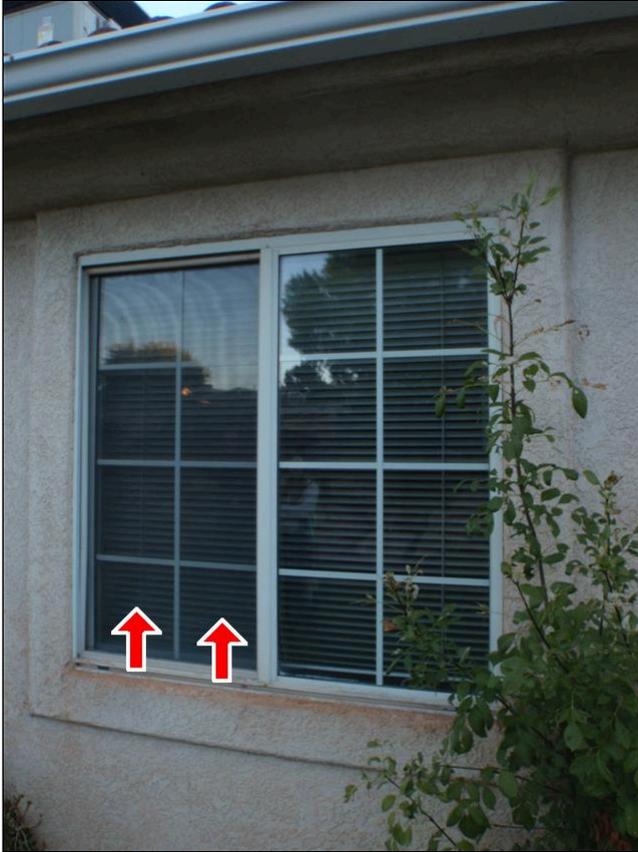
2.2 Item 1(Picture)

2.2 (1) Rear corner guest bedroom window pane is broken. Recommend repair, replace or correct by a licensed window contractor.

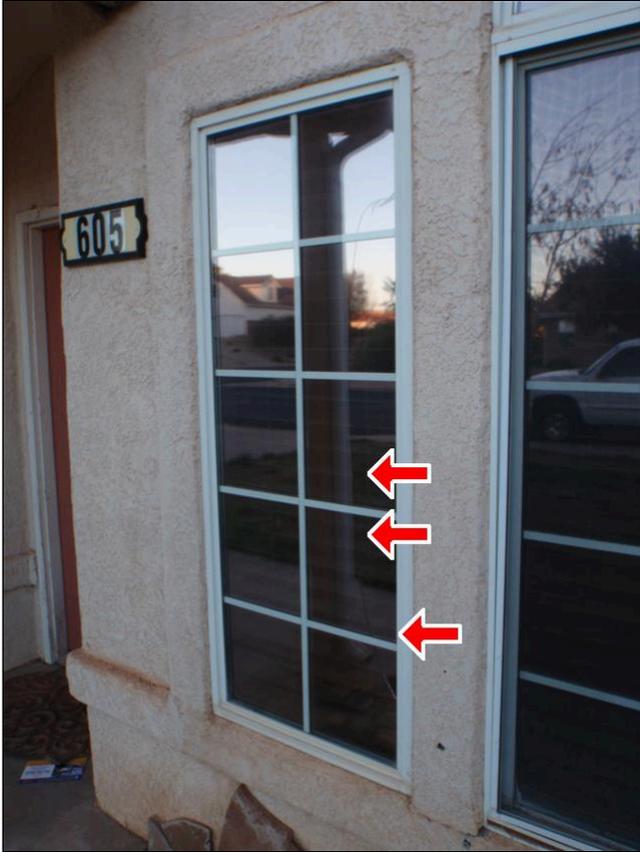
2.2 Item 2(Picture)

(2) Front living area window pane is broken. Recommend repair, replace or correct by a licensed window contractor.

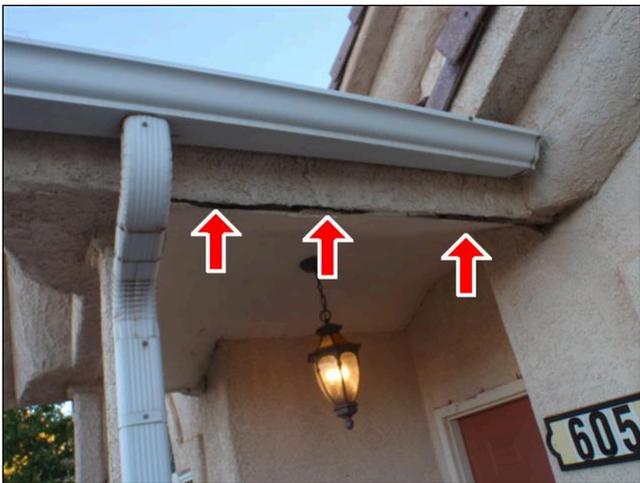
2.3 Item 1(Picture)

2.3 Front entry way ceiling damaged where it meets the stucco. Recommend repair, replace or correct by a licensed building contractor.

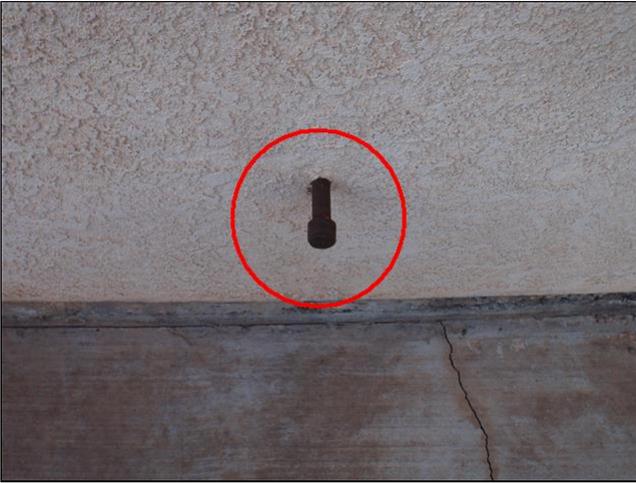
2.5 Item 1(Picture)

2.5 FYI. Natural gas BBQ or fire pit connection at rear patio.

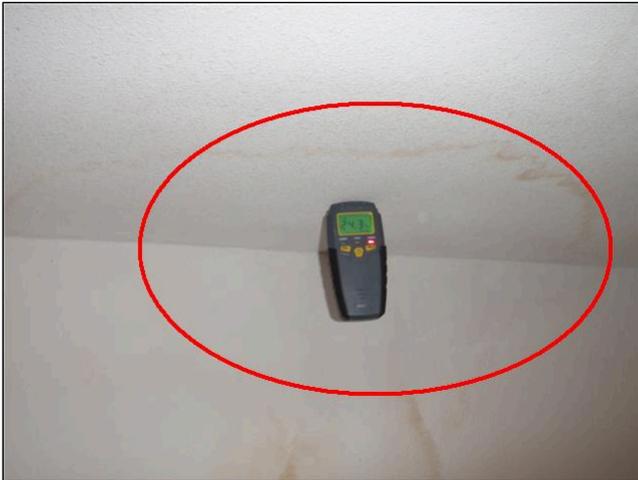
3.0 Item 1(Picture)

3.0 Garage ceiling shows signs of moisture/roof leak (above rear occupant door), wet at time of inspection. Recommend repair, replace or correct after roof leak is repaired by a licensed building contractor.

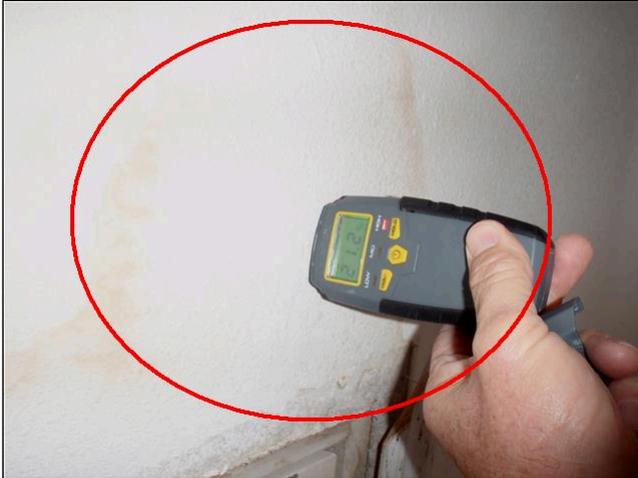
3.1 Item 1(Picture)

3.1 Garage wall shows signs of moisture/roof leak (above rear occupant door), wet at time of inspection. Recommend repair, replace or correct after roof leak is repaired by a licensed building contractor.

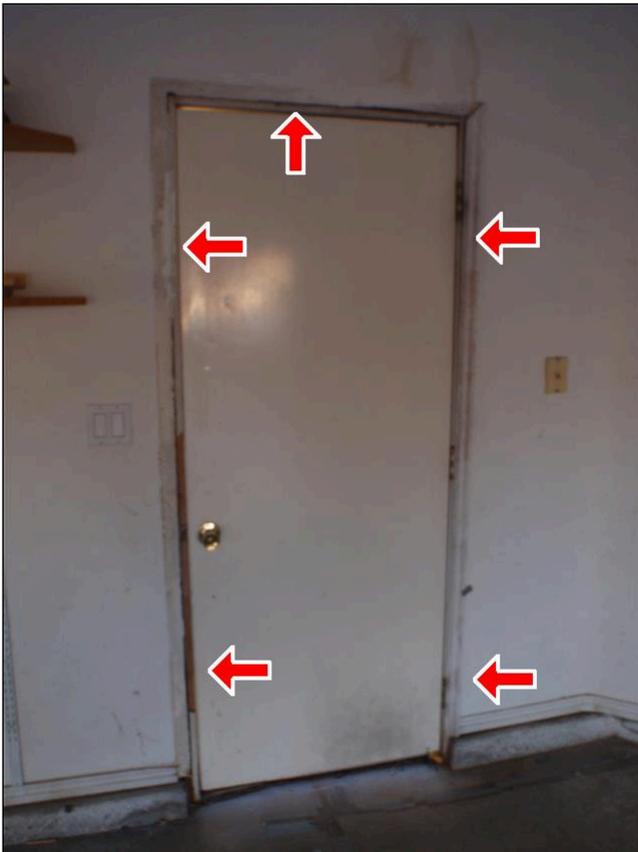
3.4 Item 1(Picture)

3.4 Garage rear occupant door trim is missing. Recommend repair, replace or correct by a qualified person.

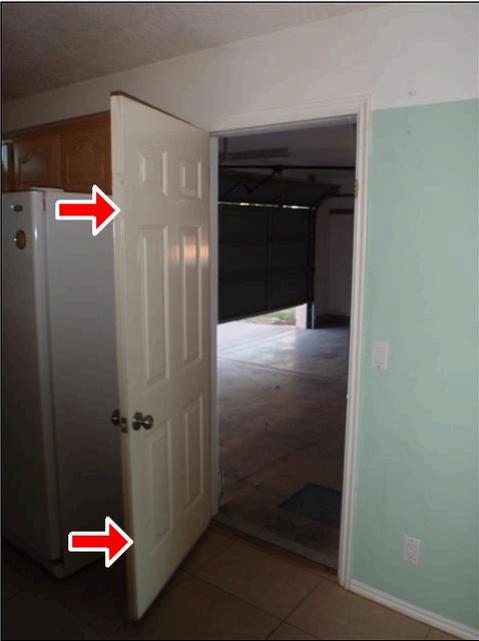
3.5 Item 1(Picture)

3.5 The occupant door from the attached garage to the inside of the house does not self close, the self closing spring hinge is missing or not functional. The purpose is to keep a garage fire from spreading to the house. Recommend repair, replace or correct by a quality tradesman.

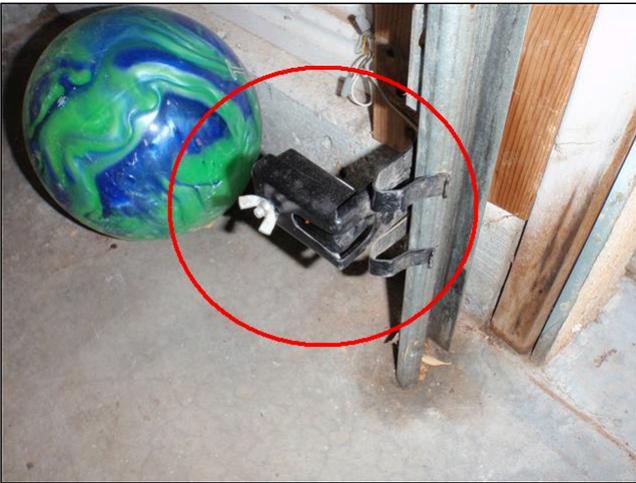
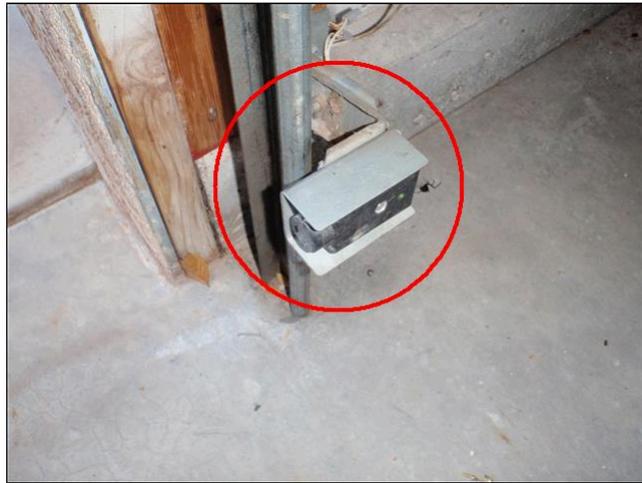
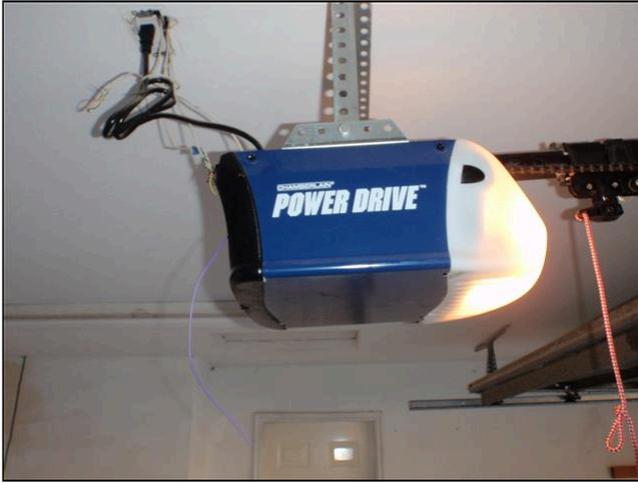
3.6 The sensors are in place for garage door and will reverse the door. The garage door will reverse when met with resistance as well.

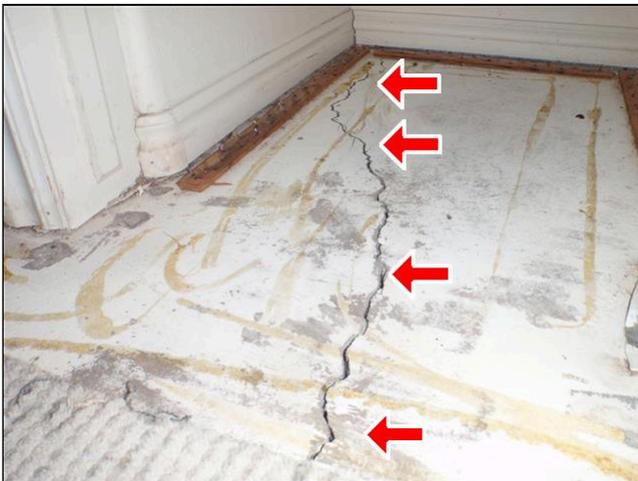
4.2 Item 1(Picture)

4.2 Concrete slab crack runs through hallway. Recommend further evaluation by a licensed foundation or building contractor.

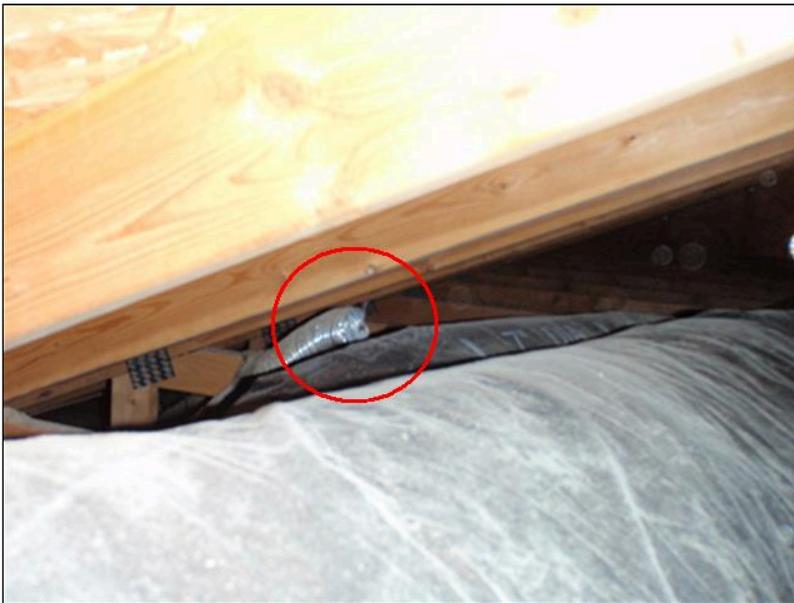
5.2 Item 1(Picture)

5.2 The bathroom exhaust fans are venting into the attic. Vent pipes that terminate in attic space can sometimes cause moisture that can lead to mold or cause condensation. A qualified contractor should inspect and repair as needed.

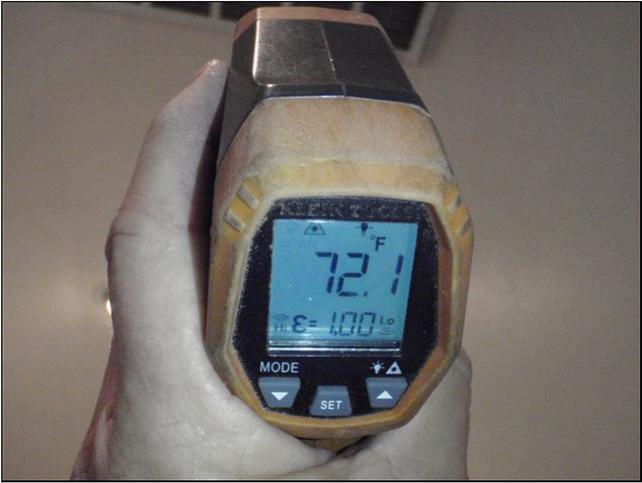
6.4 Item 2(Picture)

6.4 The HVAC cooling system appears to be functioning at time of inspection.

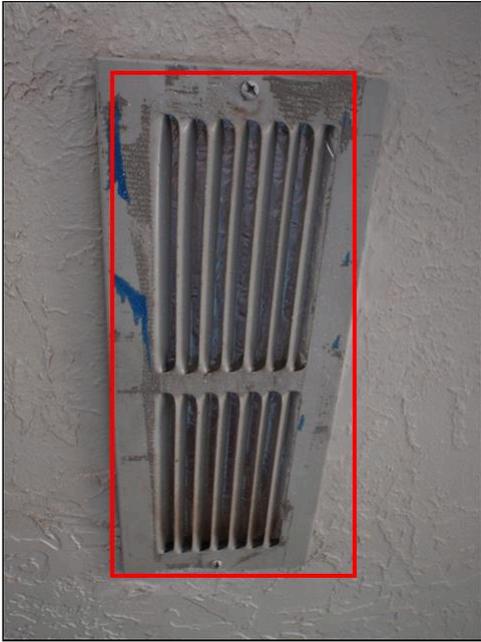
6.7 Item 1(Picture)

6.7 (1) Dining area HVAC register blocked off. Recommend repair or correct by a qualified person.

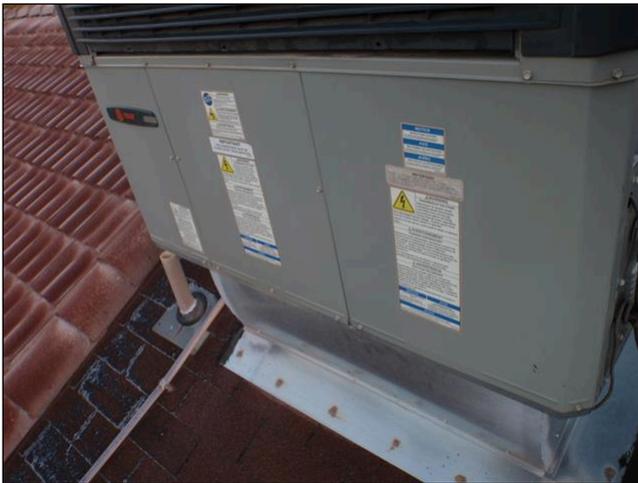
6.7 Item 2(Picture)

(2) The combination HVAC system appears to be functioning at time of inspection. Combination unit manufactures date is the 16th week of 2014.

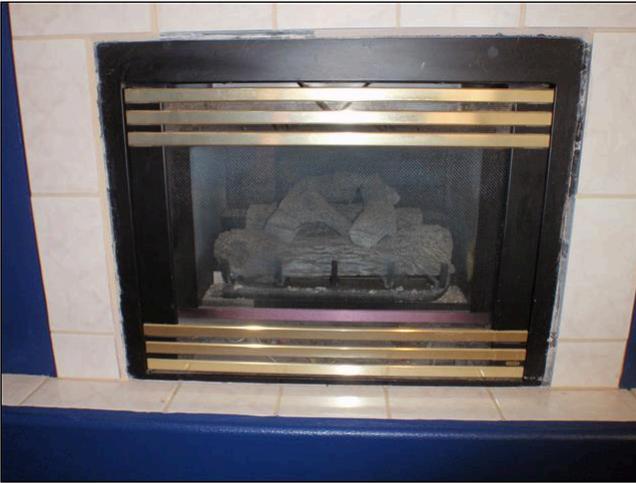
6.9 Item 1(Picture)

6.9 Natural gas fireplace unit appears to be functioning at the time of inspection, although very dirty and the fireplace wall switch did not function. Recommend natural gas fireplace unit be serviced by a licensed natural gas fireplace contractor.

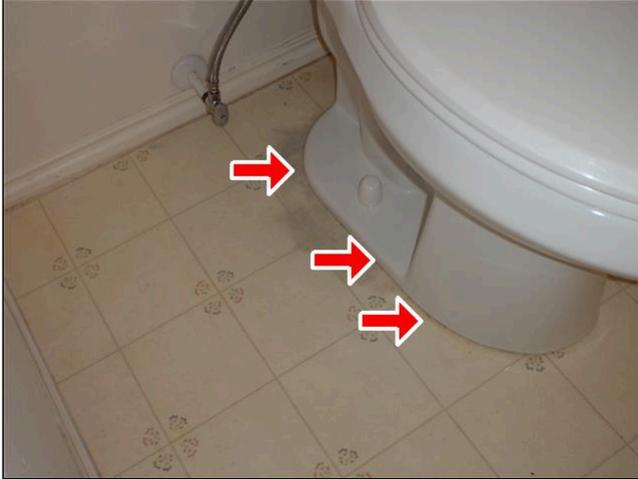
7.0 Item 1(Picture)

7.0 (1) Master bathroom toilet is loose from the floor. Repairs may involve re-setting the toilet on a new wax seal. Recommend repair or correct by a licensed plumbing contractor.

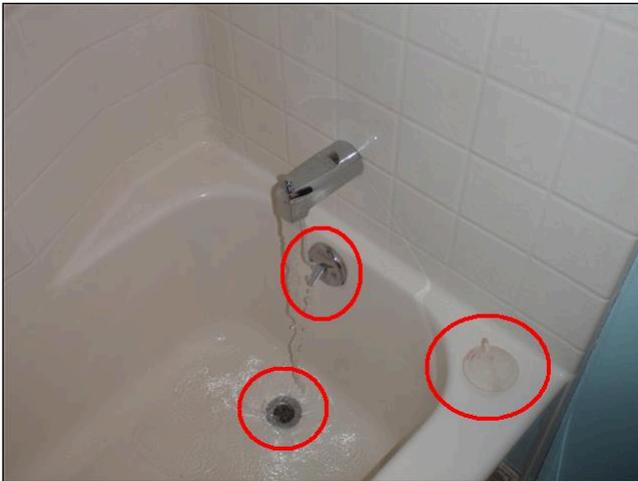
7.0 Item 2(Picture)

(2) Guest bathroom bath tub plunger does not function. Recommend repair, replace or correct by licensed plumbing contractor.

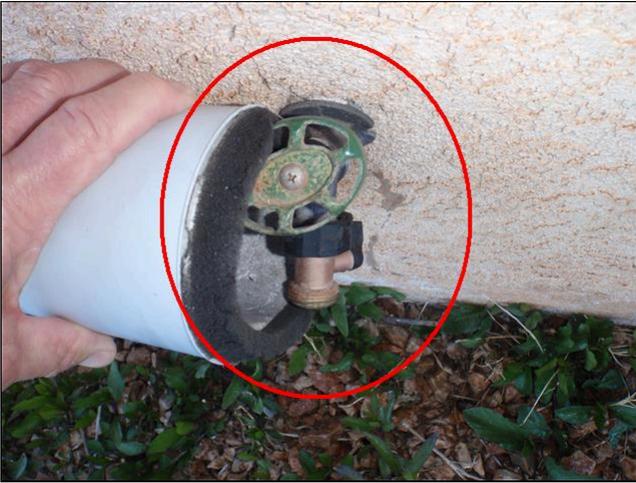
7.1 Item 1(Picture)

7.1 (1) FYI. Two old hose bibs on the old plumbing system will not function.

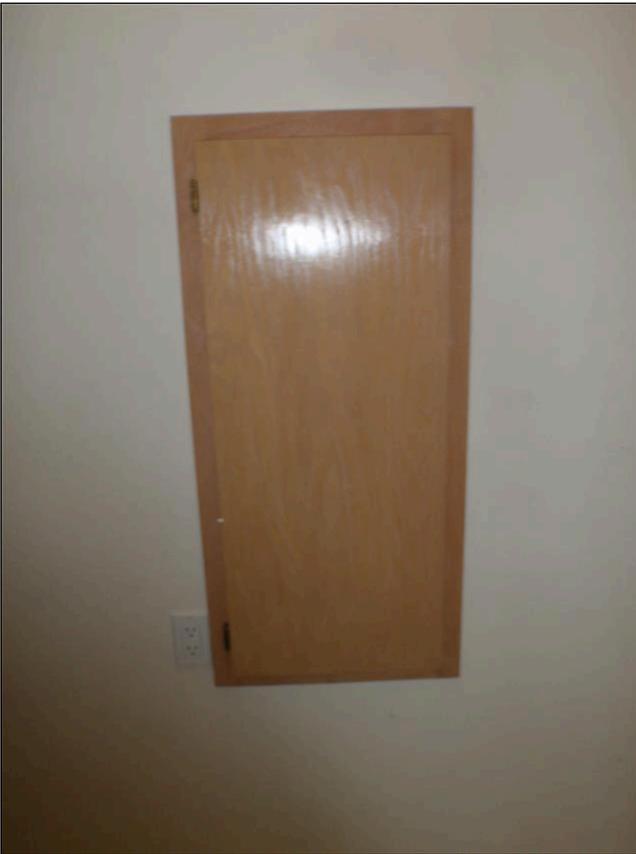
7.1 Item 3(Picture)

(2) FYI. Old poly water pipe system manifold removed. Cabinet located in laundry room.

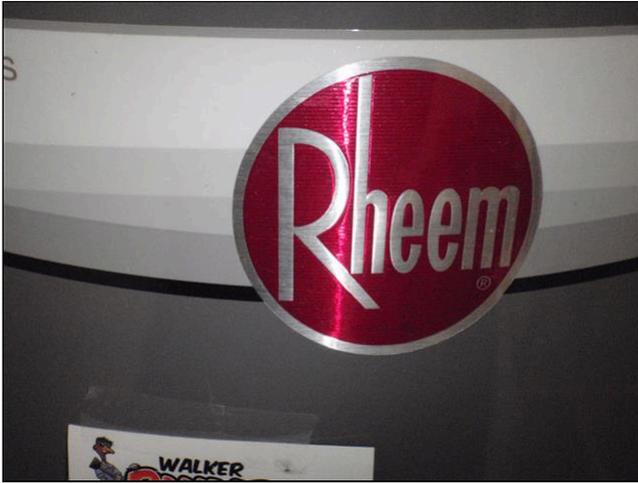
7.2 Item 1(Picture)

7.2 (1) Water heater manufacture date is August 31st 2020.

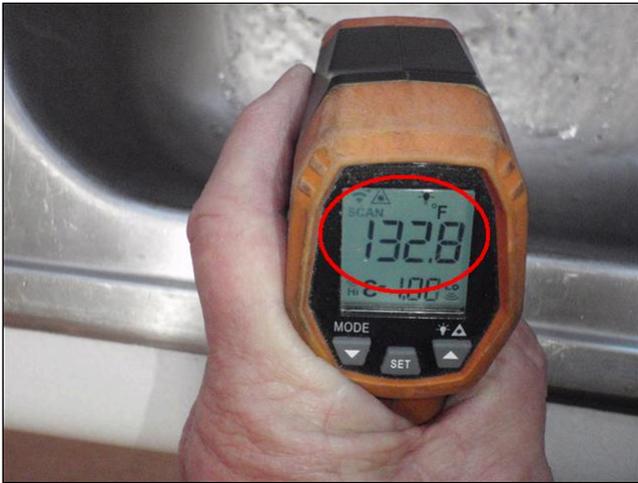
7.2 Item 3(Picture)

(2) Hot water temperature at the time of the inspection.

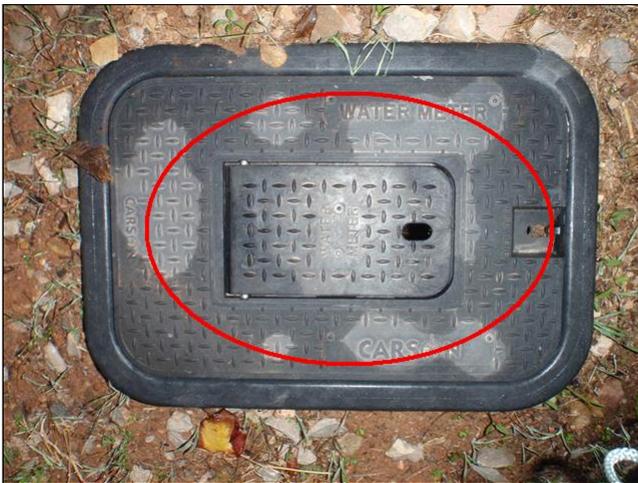
7.3 Item 1(Picture)

7.3 (1) The main water shut off is located next to the water meter.

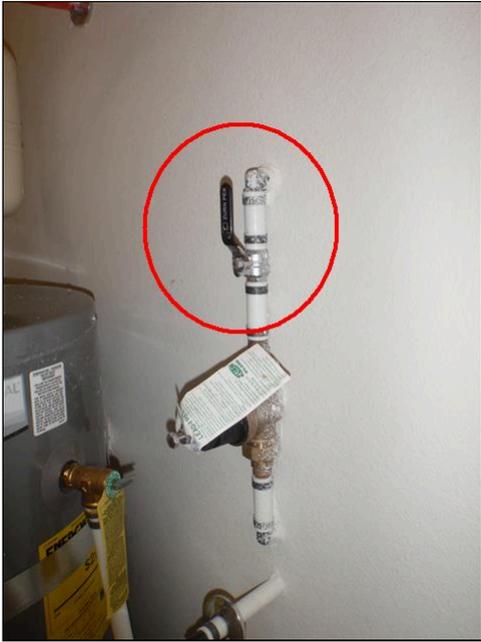
7.3 Item 3(Picture)

(2) The second main water shut off is located in the laundry room next to the water heater.

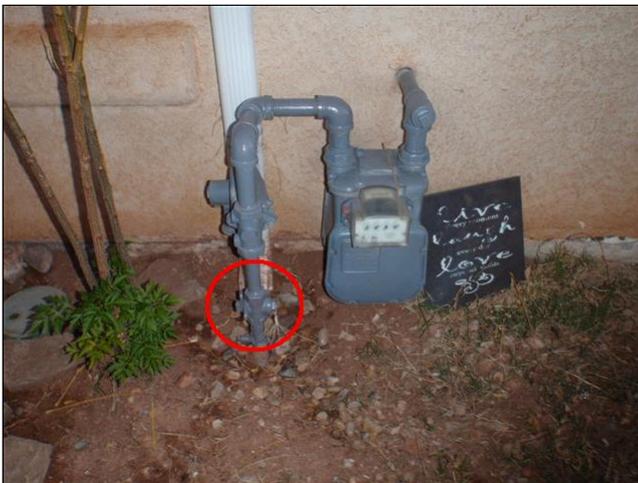
7.5 Item 1(Picture)

7.5 The main gas shut off is at gas meter outside.

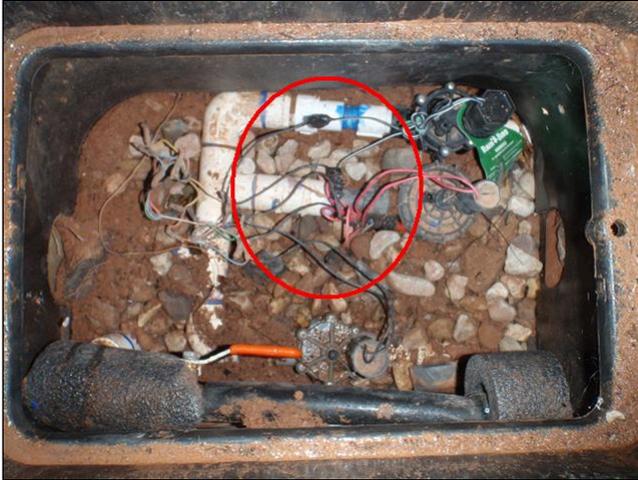
7.6 Item 1(Picture)

7.6 Sprinkler valve wires should be connected with moisture resistant wire connectors. Recommend repair or correct by a qualified person.

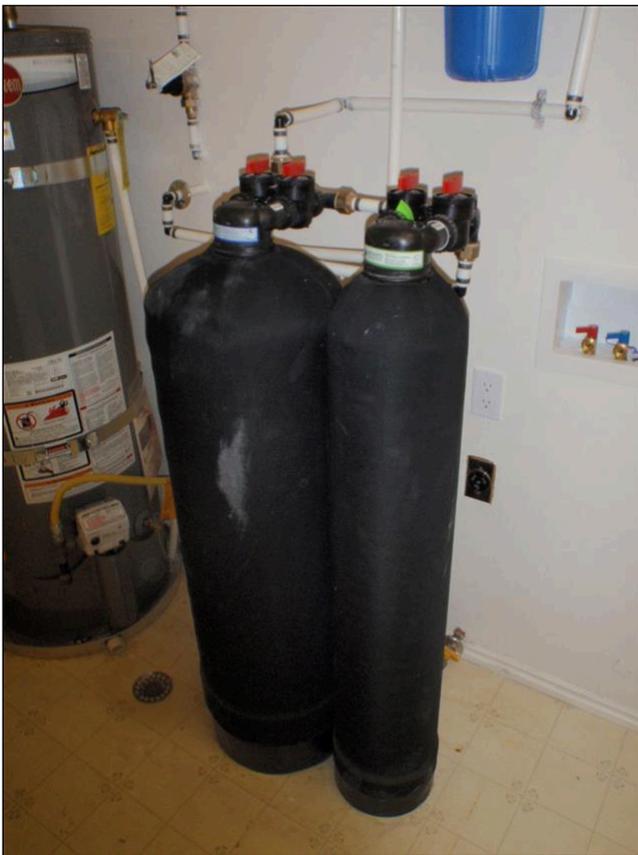
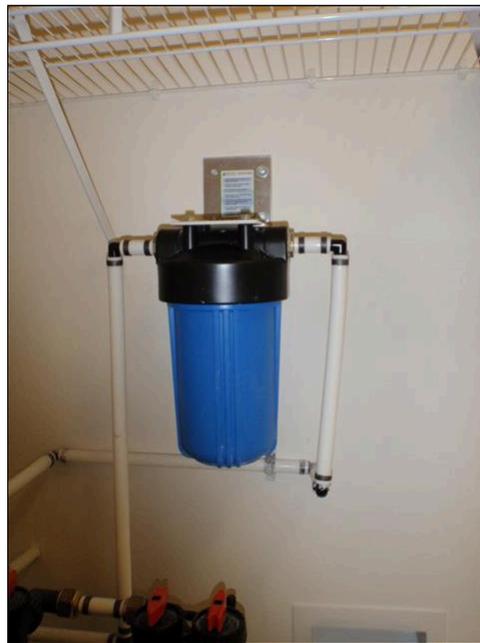
7.7 Water filtration system appears to be functioning at time of inspection, although we recommend having system serviced by a licensed plumbing contractor.

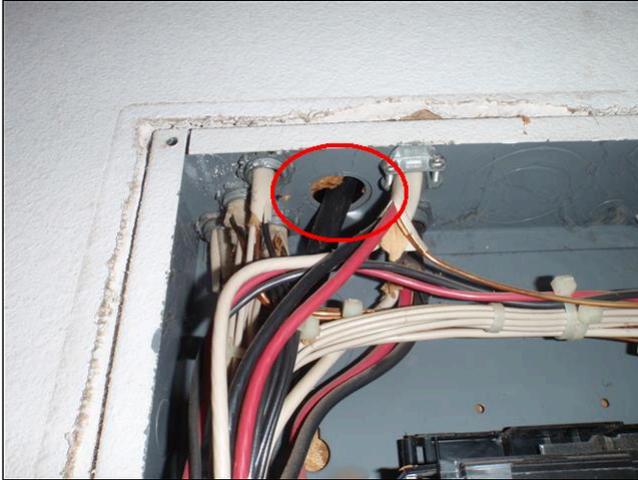
8.1 Item 1(Picture)

8.1 Circuit missing wire clamp in main electrical panel. Recommend repair, or correct by a licensed electrical contractor.

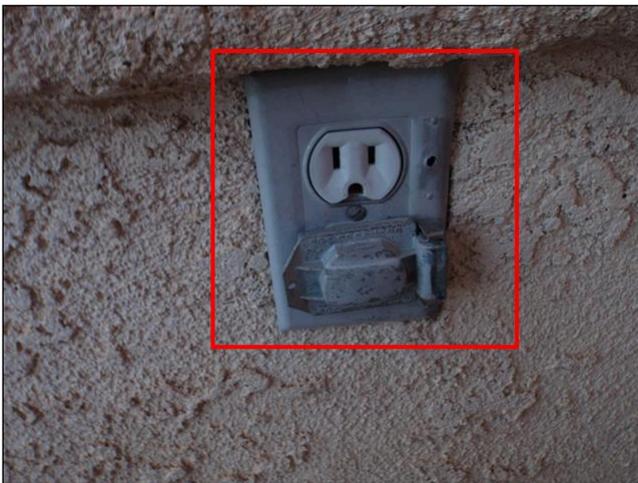
8.3 Item 1(Picture)

8.3 (1) Front entry area electrical outlet is missing weather resistant cover. Recommend replacing cover by a qualified person.

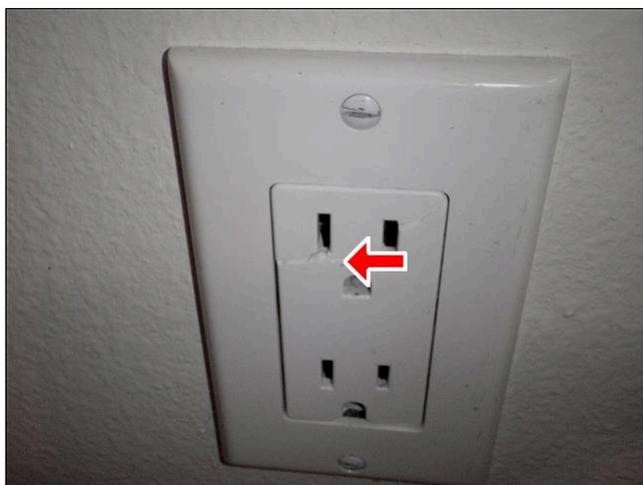
8.3 Item 2(Picture)

(2) Master bedroom electrical outlet cracked. Recommend replace or correct by a licensed electrical contractor.

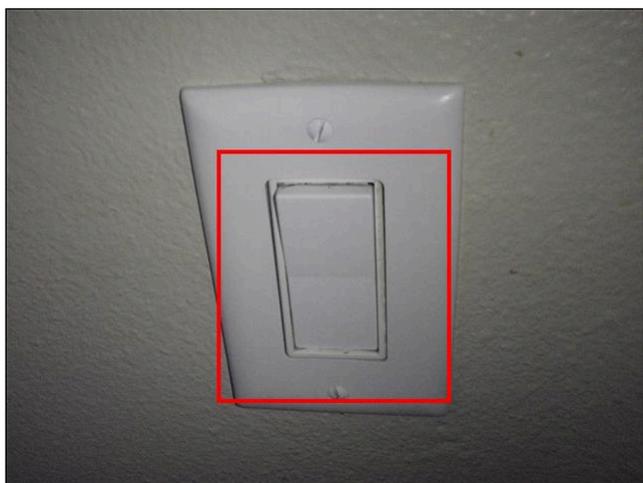
8.3 Item 3(Picture)

(3) Rear corner guest bedroom light switch is warped. Heat can cause them to warp. Recommend repair, replace or correct by a licensed electrical contractor.

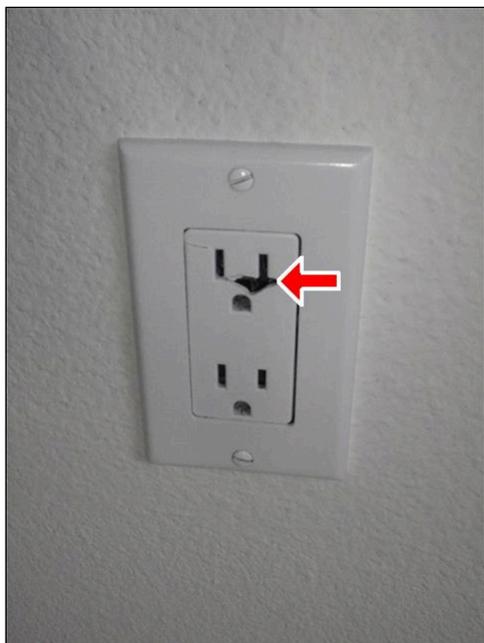
8.3 Item 4(Picture)

(4) West guest bedroom electrical outlet cracked. Recommend replace or correct by a licensed electrical contractor.

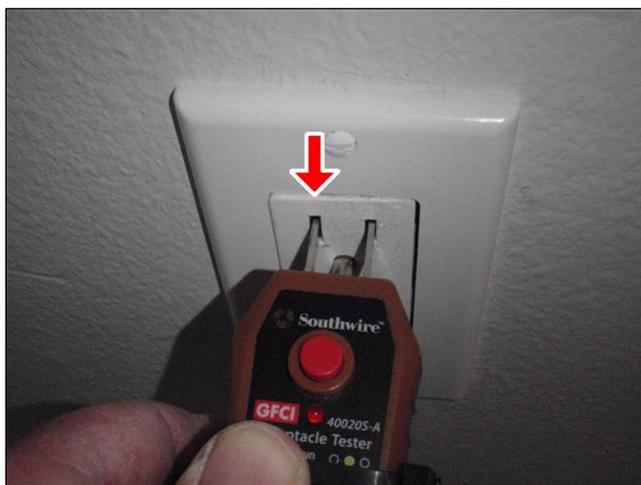
8.3 Item 5(Picture)

(5) Electrical outlet in dining area, can not insert plug. Recommend repair, replace or correct by a licensed electrical contractor.

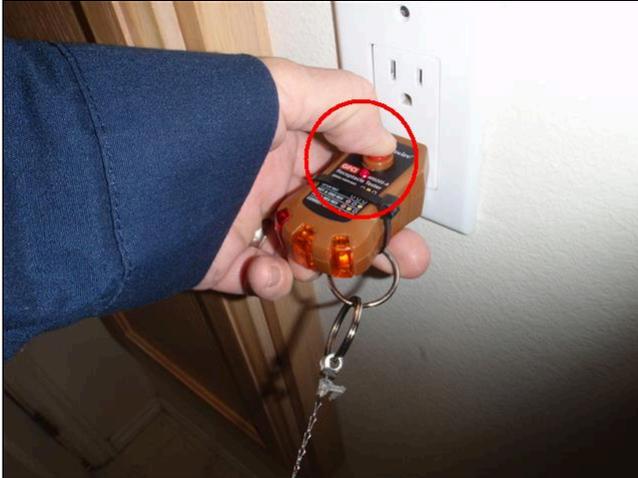
8.5 Item 1(Picture)

8.5 (1) Laundry room electrical outlets are not GFCI protected. Recommend installing GFCI receptacles for safety by a licensed electrician.

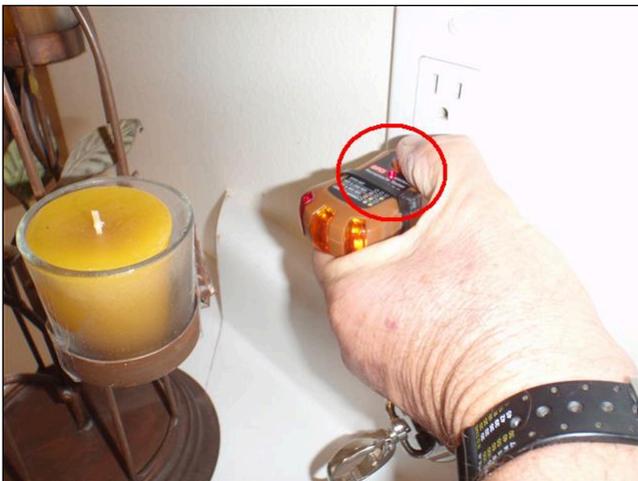
8.5 Item 2(Picture)

(2) One kitchen electrical outlet is not GFCI protected. Recommend repair, replace or correct by a licensed electrical contractor.

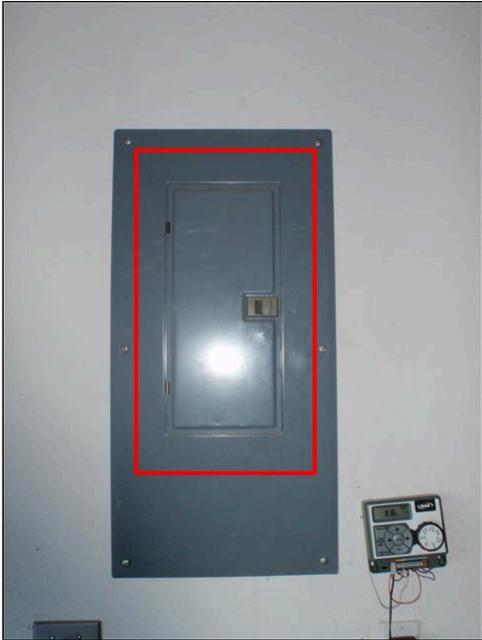
8.6 Item 1(Picture)

8.6 The main electrical panel box including the main shut off is located in the garage.

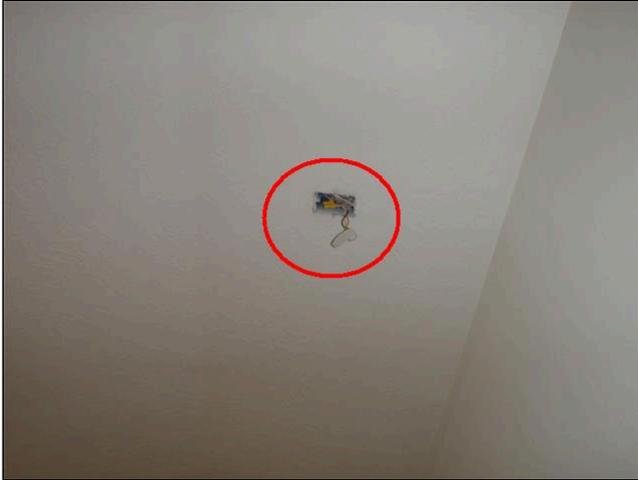
8.7 Item 1(Picture)

8.7 (1) All three bedrooms missing smoke detectors. Recommend installing smoke detectors by a qualified person.

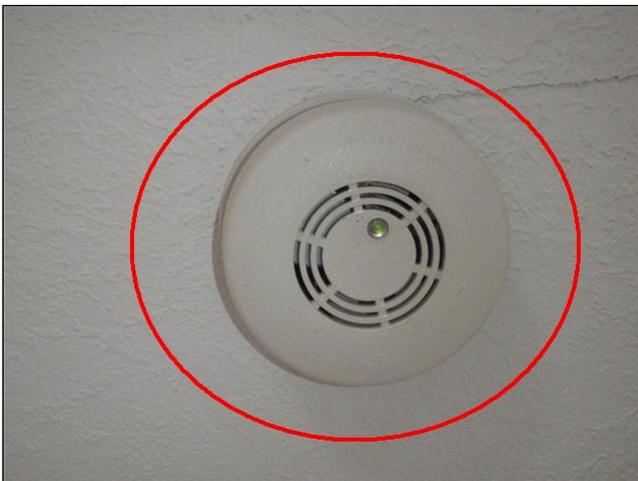
8.7 Item 4(Picture)

(2) The hallway smoke detector is old and its color has changed. Recommend replace smoke detector as per manufacturers instructions.

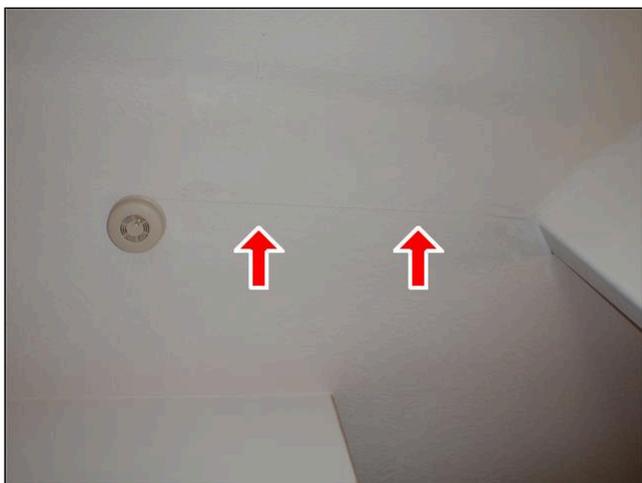
9.0 Item 1(Picture)

9.0 FYI. Drywall ceiling crack. Temperature fluctuations can cause the drywall to expand and contract creating stress that cracks the seems. The building is always settling, and this causes stress to the walls that can create a crack in the drywall. Recommend repair and paint by a qualified person as desired.

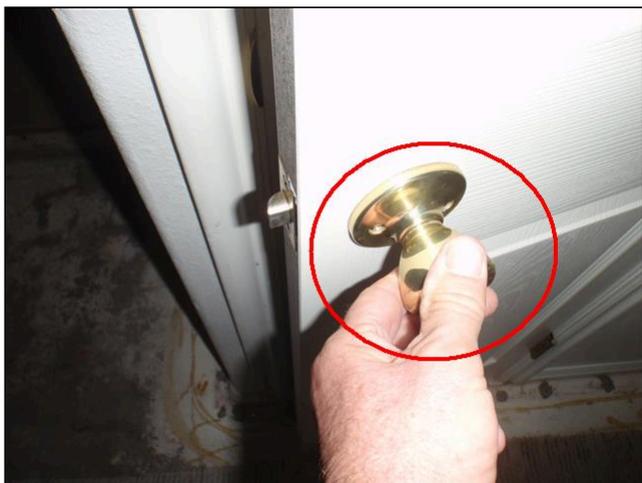
9.3 Item 1(Picture)

9.3 Hallway closet door knob hard to turn. Recommend repair, replace or correct by a qualified person.

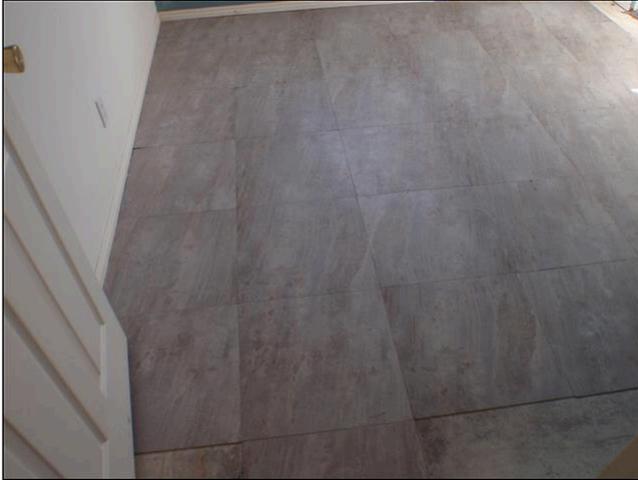
10.2 Item 1(Picture)

10.2 All interior flooring is old, damaged or missing. Recommend repair, replace or correct by a licensed flooring contractor.
