Inspection Report

Sample Report

Property Address:
5741 Sample Property Drive
Washington UT 84780

Blue Majestic Home Inspections LLC

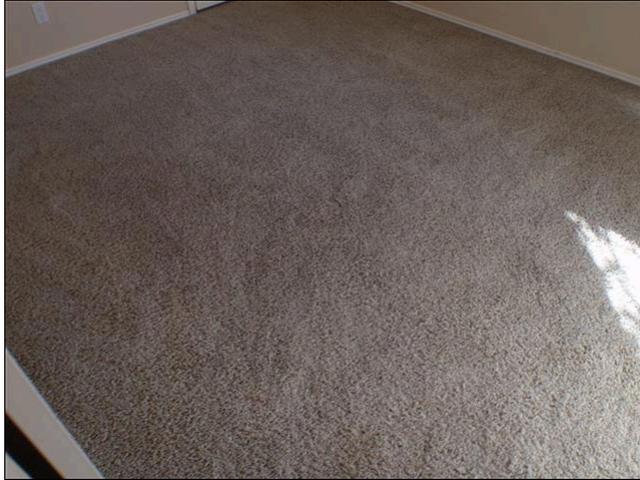
10.2 Item 2(Picture)

10.2 All interior flooring is old, damaged or missing. Recommend repair, replace or correct by a licensed flooring contractor.

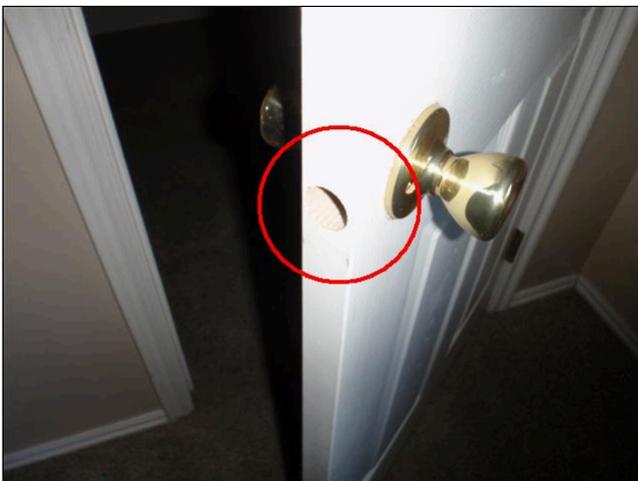
10.3 Item 1(Picture)

10.3 (1) Rear corner bedroom closet door latch missing. Recommend replace or correct by a qualified person.

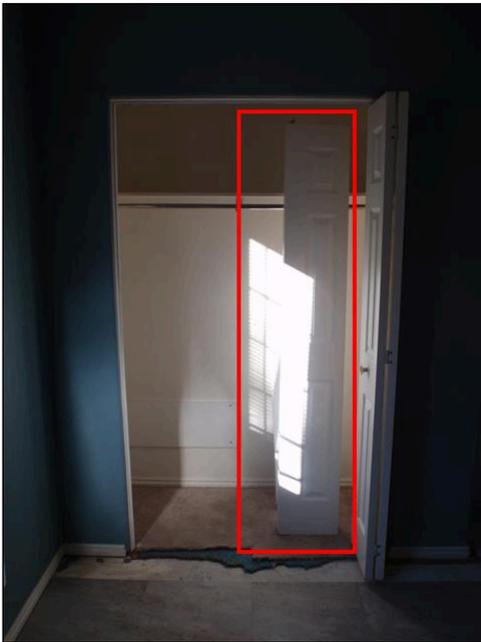
10.3 Item 2(Picture)

(2) Middle bedroom closet door not in place. Recommend repair, replace or correct by a qualified person.

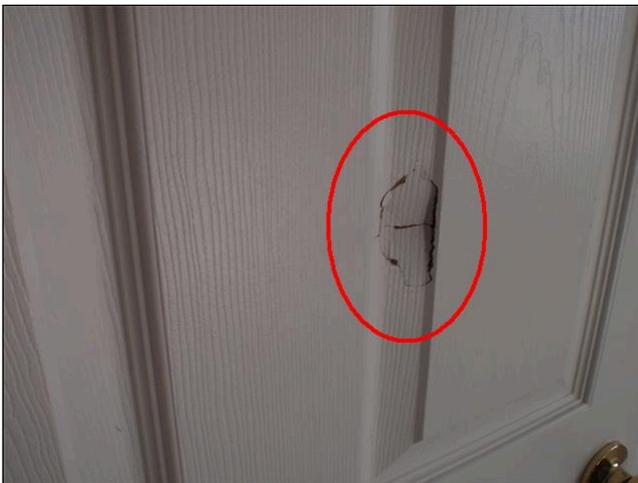
10.3 Item 4(Picture)

(3) Middle guest bedroom door has a hole in it. Recommend repair or correct by a qualified person.

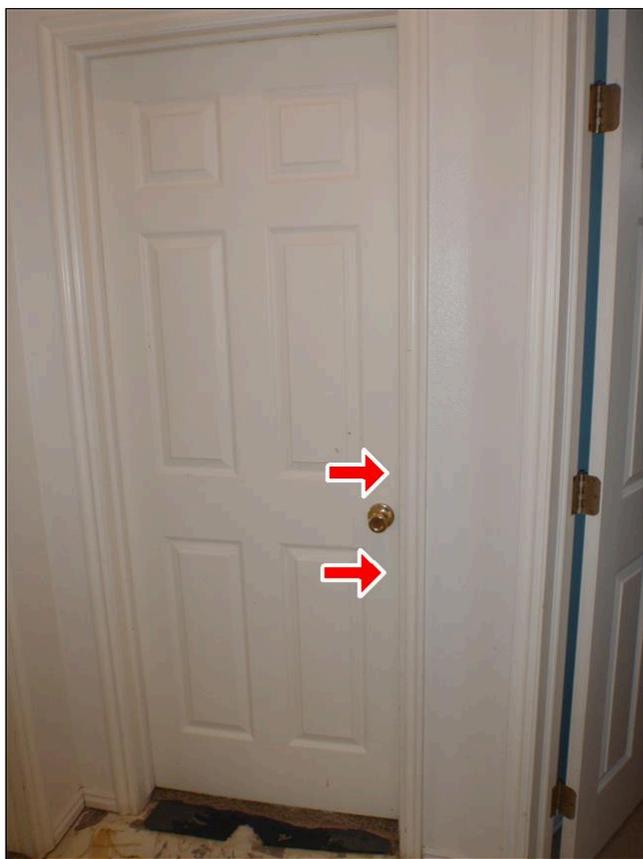
10.3 Item 5(Picture)

(4) Rear corner bedroom door hitting door jamb. Recommend repair or correct by a qualified person.

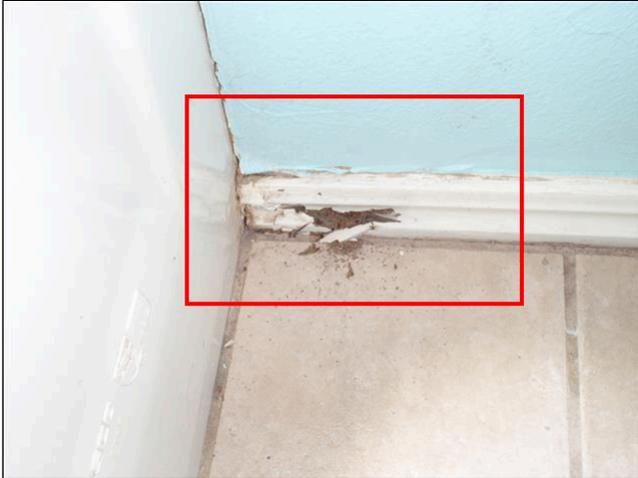
11.1 Item 1(Picture)

11.1 Guest bathroom lower wall trim shows sign of wood rot as well as termite intrusion. Recommend repair or correct by a licensed pest control and building contractor.

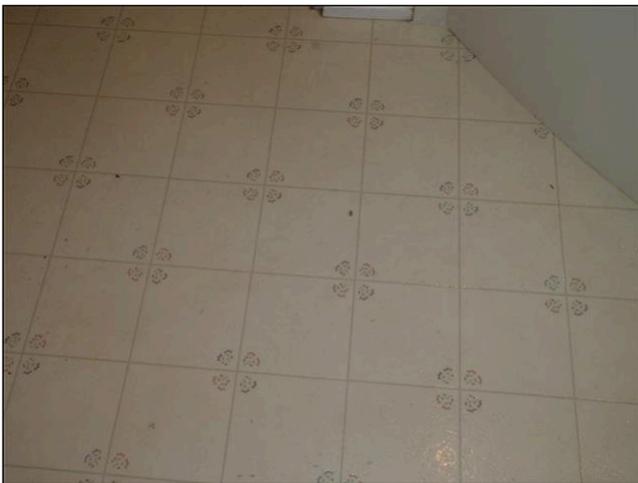
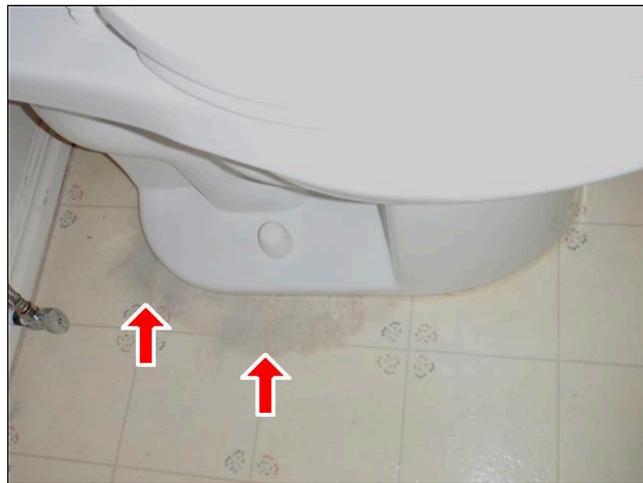
11.2 Master bathroom vinyl floor shows signs of wear, chips and stains in areas. Recommend repair, replace or correct by a licensed flooring contractor.

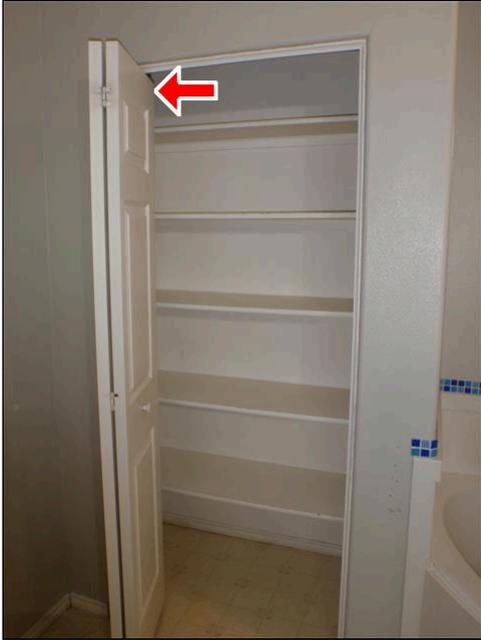
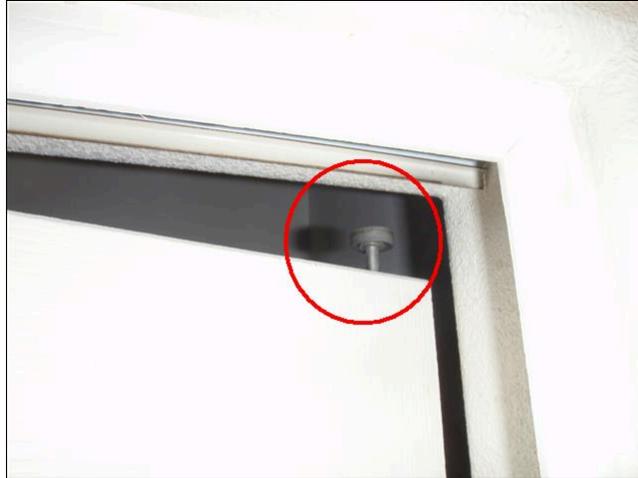
11.4 Item 1(Picture)

11.4 Master bathroom closet door upper roller does not stay in track. Recommend repair, replace or correct by a qualified person.

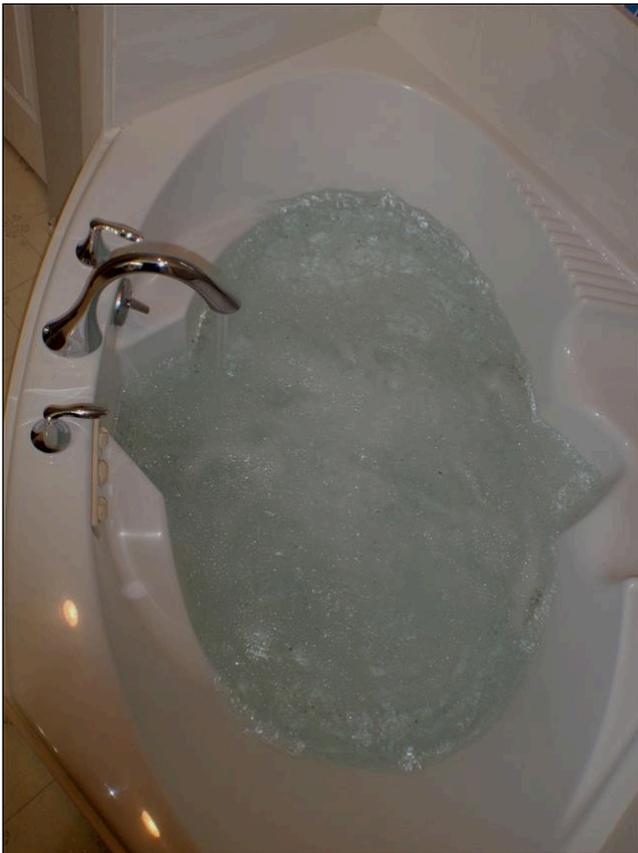
11.8 Item 1(Picture)

11.8 Spa tub appears to function at the time of the inspection.

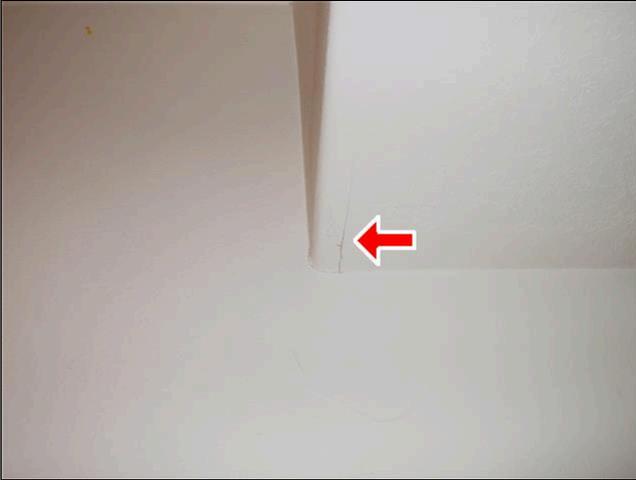
12.0 Item 1(Picture)

12.0 Kitchen ceiling drywall crack, temperature fluctuations can cause drywall to expand and contract creating stress cracks. This appears to be cosmetic at time of inspection.

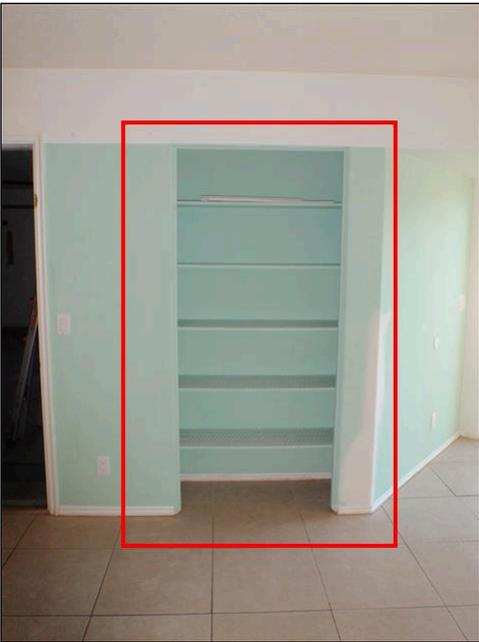
12.4 Item 1(Picture)

12.4 Kitchen pantry doors are missing. Recommend replacing doors by a licensed door contractor.

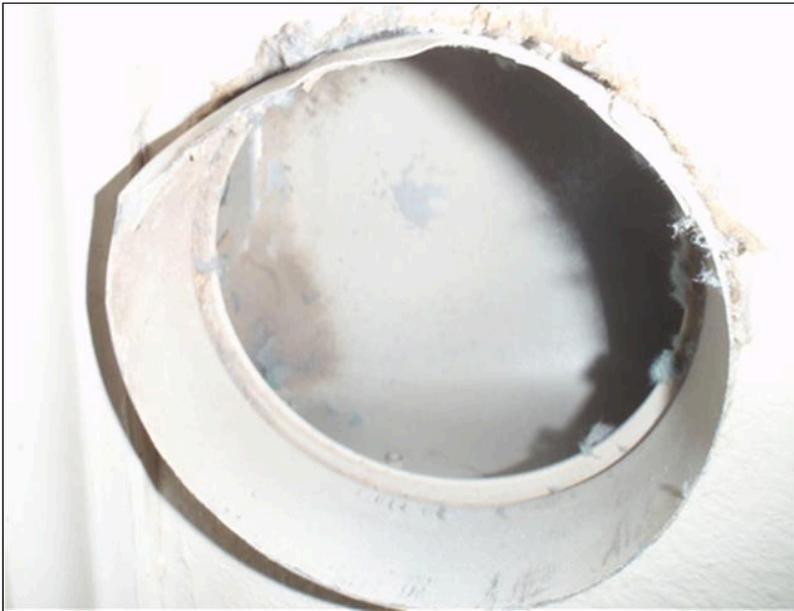
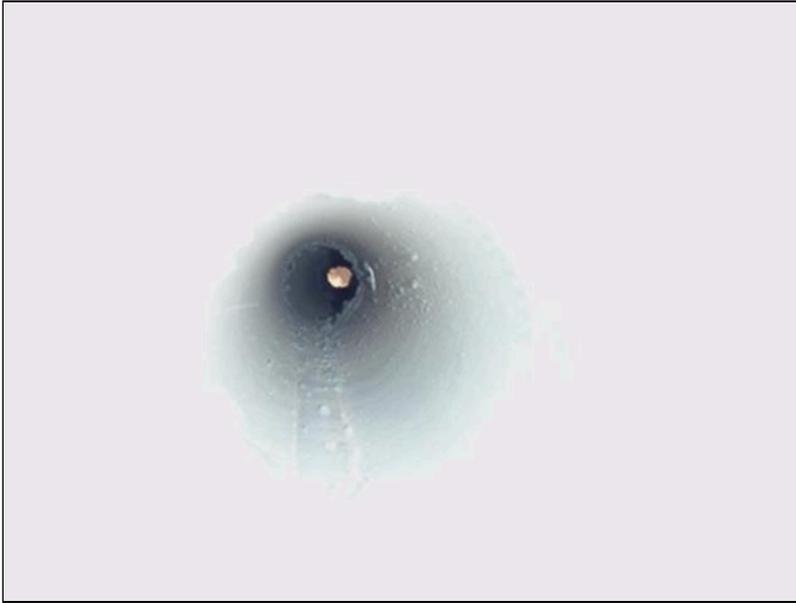
13.0 The dryer vent duct has a build-up of lint. Recommend cleaning dryer vent pipe by a qualified person.

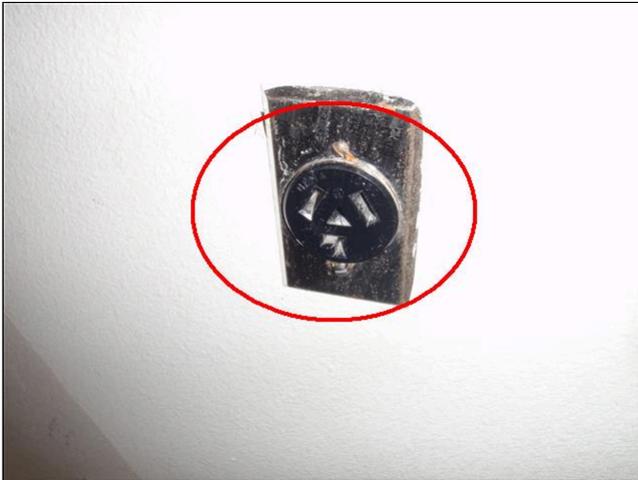
13.2 Item 1(Picture)

13.2 The dryer 220 electrical outlet appears to be the three prong type. Recommend upgrading to the newer four prong electrical outlet for newer dryers by a licensed electrical contractor.

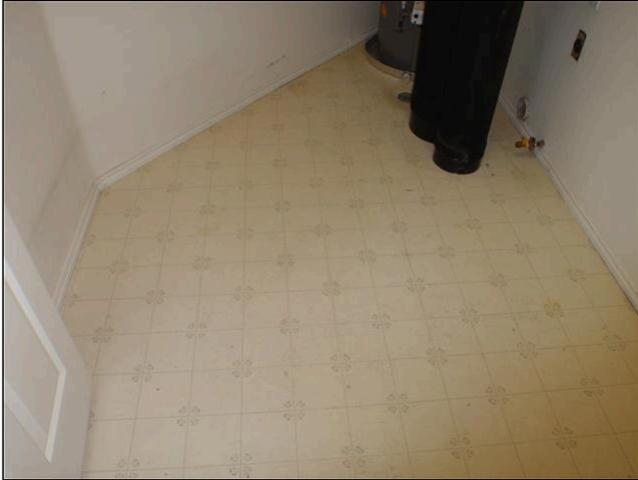
13.6 Item 1(Picture)

13.6 Laundry room flooring is old and damaged. Recommend repair, replace or correct by a licensed flooring contractor.

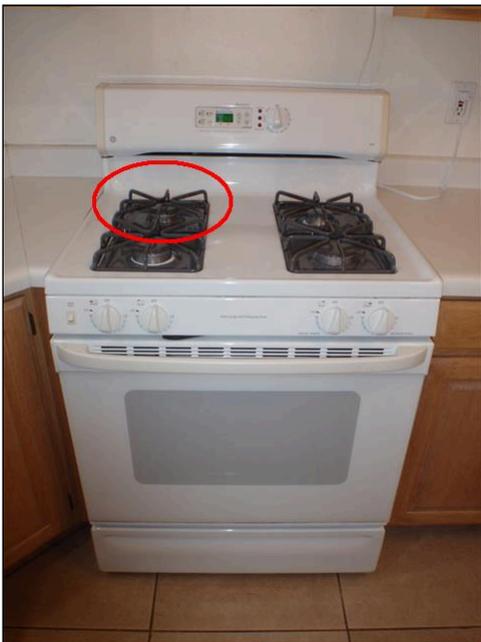
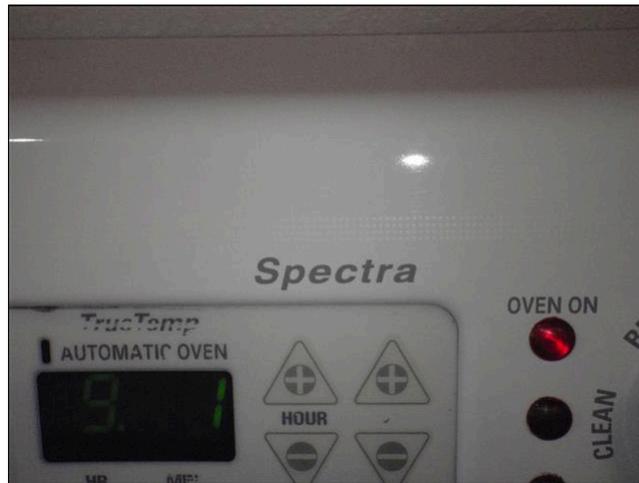
14.1 (1) The stove left rear top burner does not light. Recommend repair, replace or correct by a licensed appliance contractor.

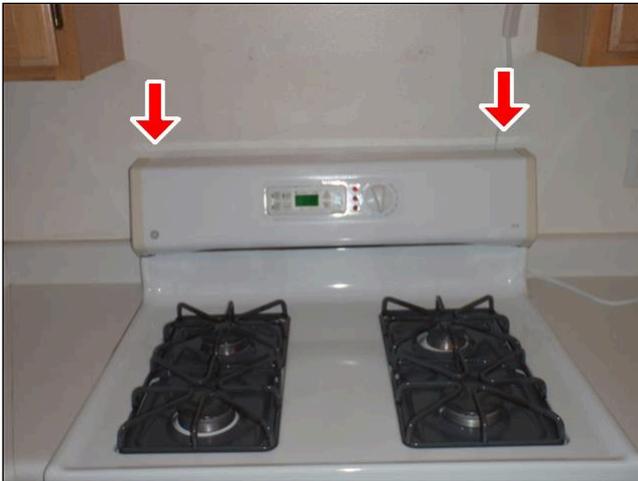
14.1 Item 3(Picture)

(2) Range Anti Tip Bracket is not installed on freestanding, slide in or drop in range. Recommend installing Anti Tip Bracket by a qualified person for safety.

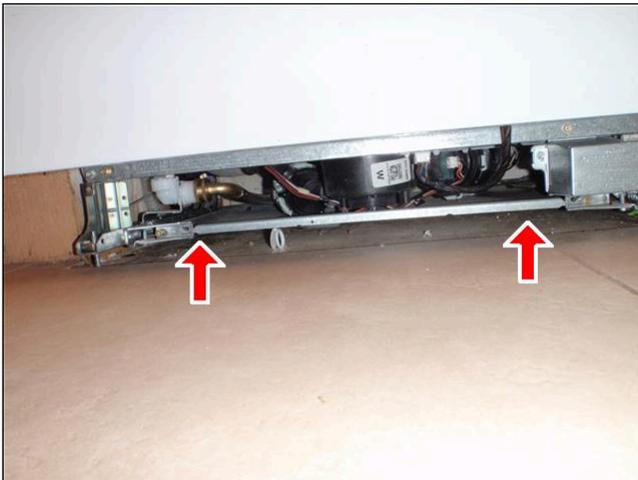
14.2 Item 1(Picture)

14.2 (1) Dishwasher lower front panel missing. Recommend replace or correct by a qualified person.

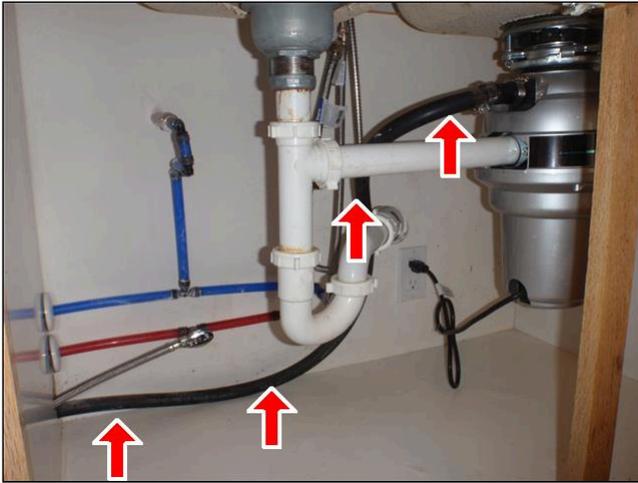
14.2 Item 2(Picture)

(2) The dishwasher was installed without a high loop in the drain hose. The drain hose must have a high loop in the hose from the floor to prevent backflow of water into the dishwasher or water siphoning out during operation. Recommend repair, replace or correct by a licensed plumbing contractor.

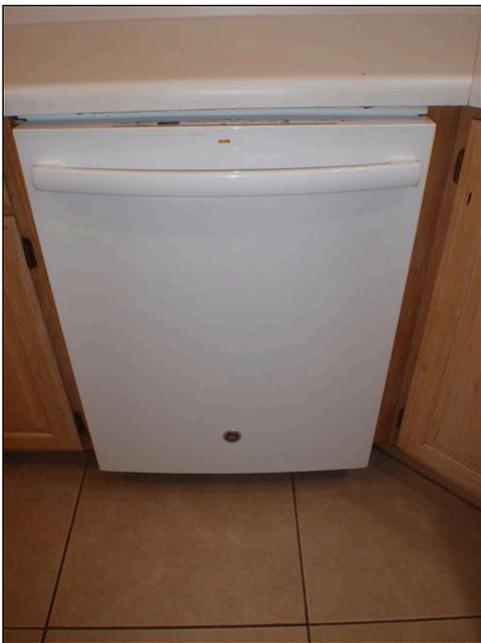
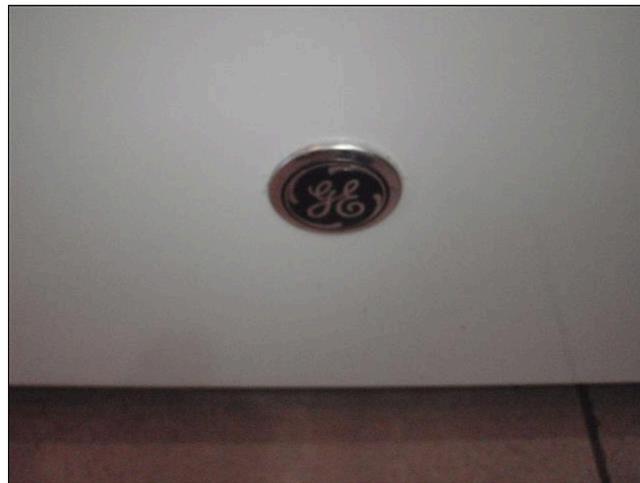
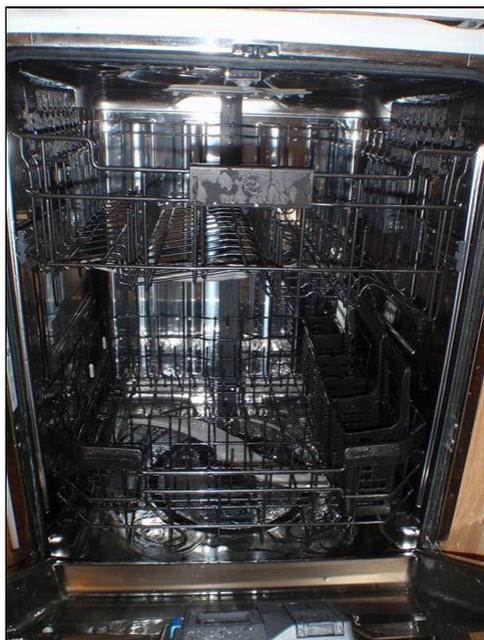
14.2 Item 3(Picture)

(3) The dishwasher appears to be functioning at the time of the inspection.

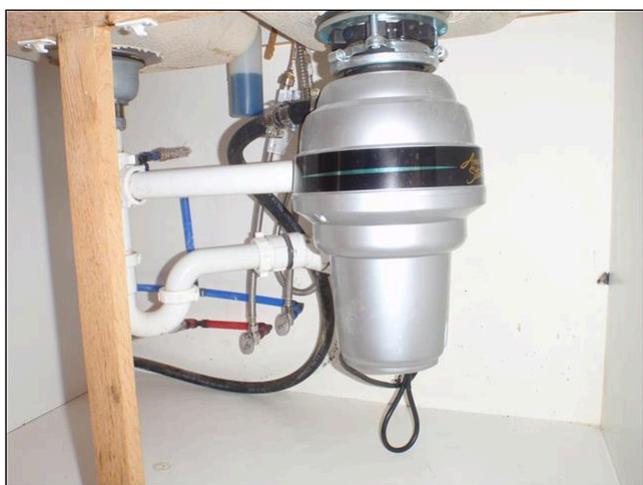
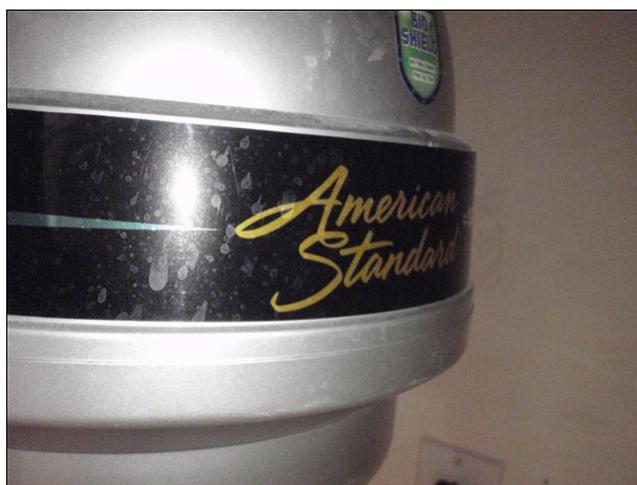
14.4 Item 1(Picture)

14.4 The garbage disposal appears to be functioning at the time of the inspection.

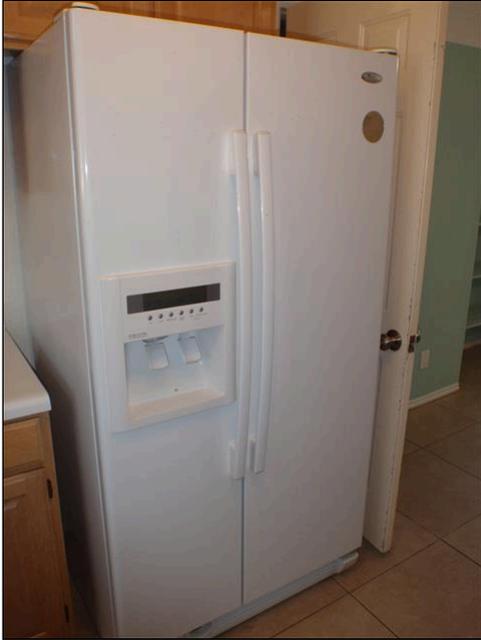
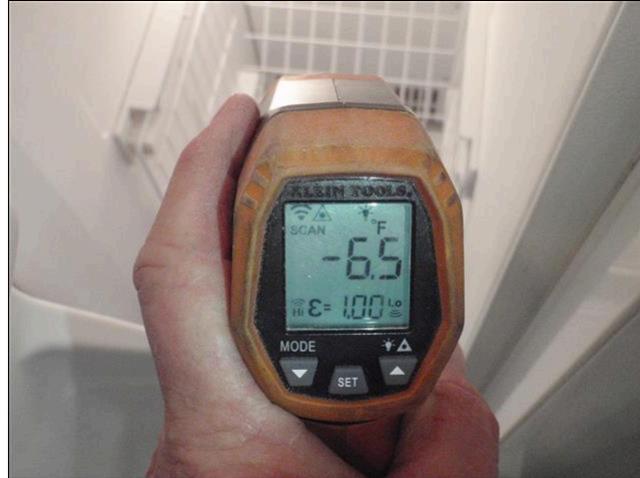
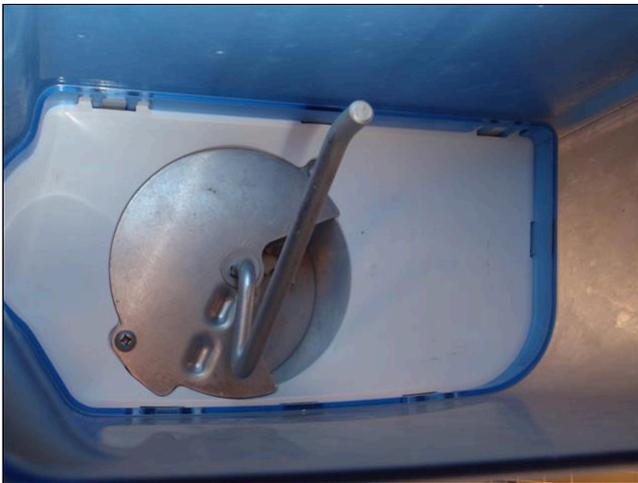
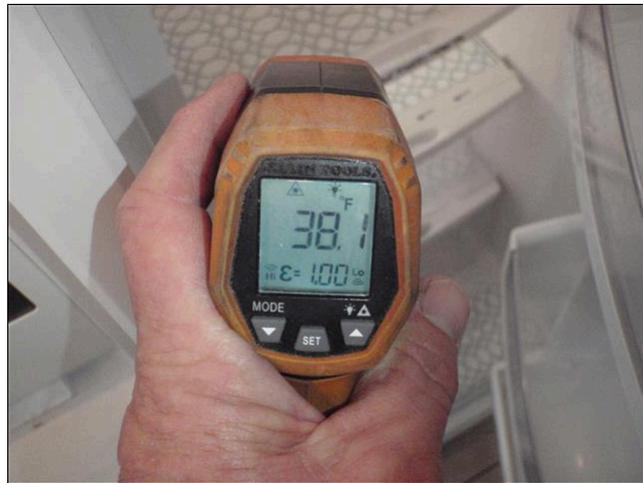
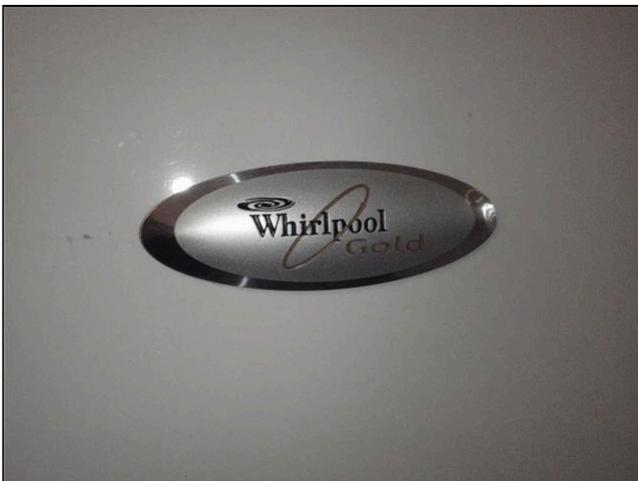
14.5 Item 1(Picture)

14.5 The refrigerator appears to be functioning at the time of inspection (Not making ice at time of inspection).

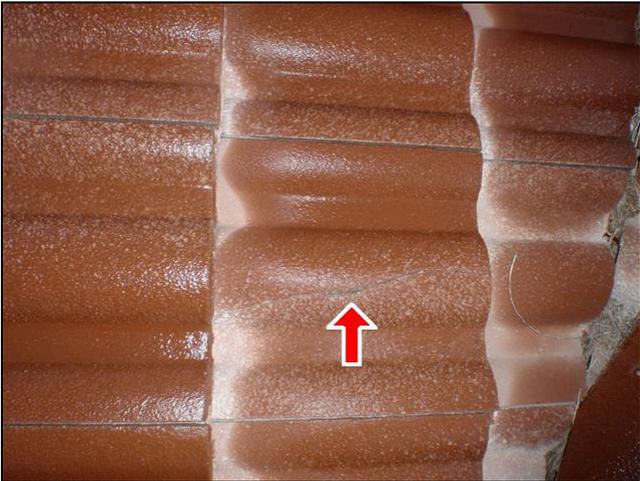
1.0 Item 2(Picture)

(1) Broken concrete roofing tiles at various areas. Recommend replace broken tiles by a licensed roofing contractor.

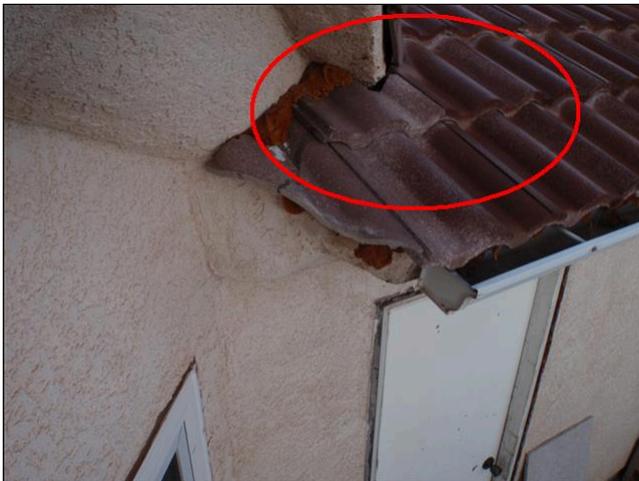
1.0 Item 8(Picture)

(3) Roof covering leak observed in the area above the garage outside occupant door, wet roof sheathing and drywall. Recommended repair, replace or correct by a licensed roofing contractor.

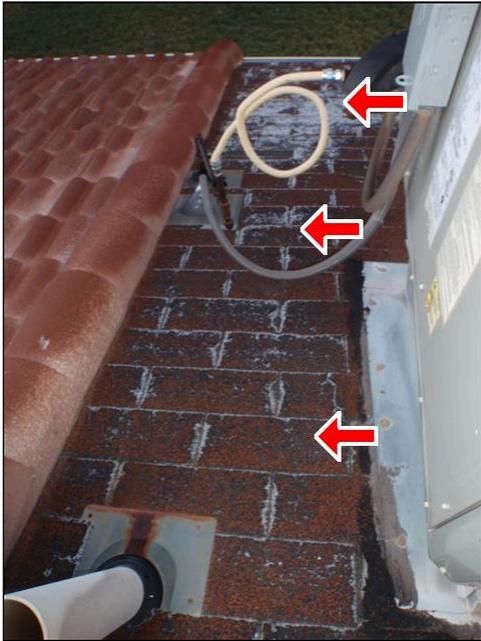
1.0 Item 14(Picture)

(4) Three tab fiberglass shingle roof covering at HVAC unit area are old and have major granular loss. The covering needs replaced. Recommend repair, replace or correct by a licensed roofing contractor.

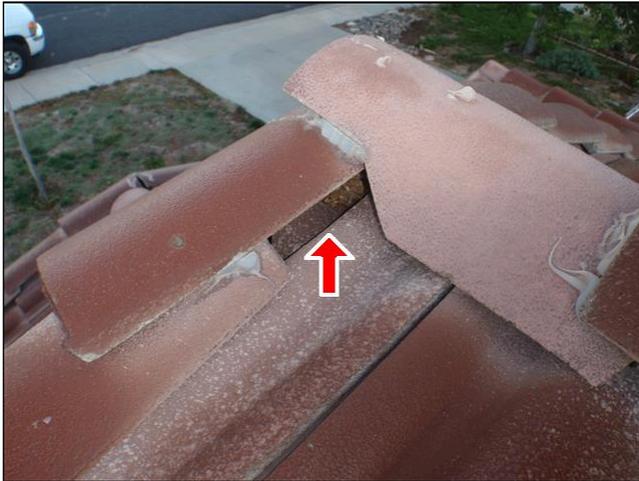
1.0 Item 18(Picture)

(5) Opening in tiles where concrete hip cap tile meets concrete ridge cap tile exposing underlayment and bare wood. Recommend seal with mastic by a licensed roofing contractor to prevent water intrusion.

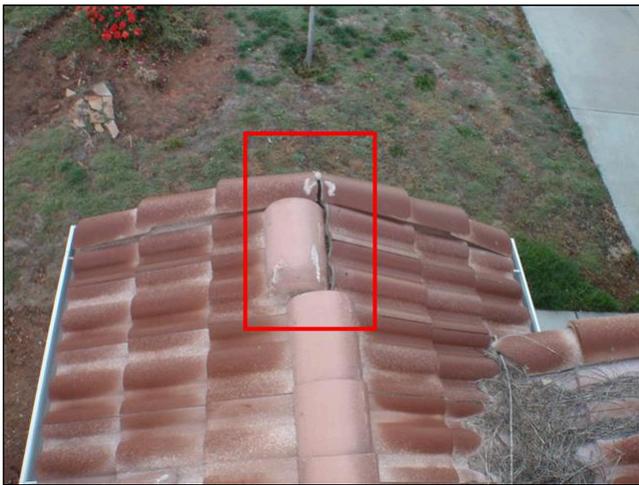
1.0 Item 19(Picture)

(6) Ridge cap tile missing. Recommend replace or correct by a licensed roofing contractor.

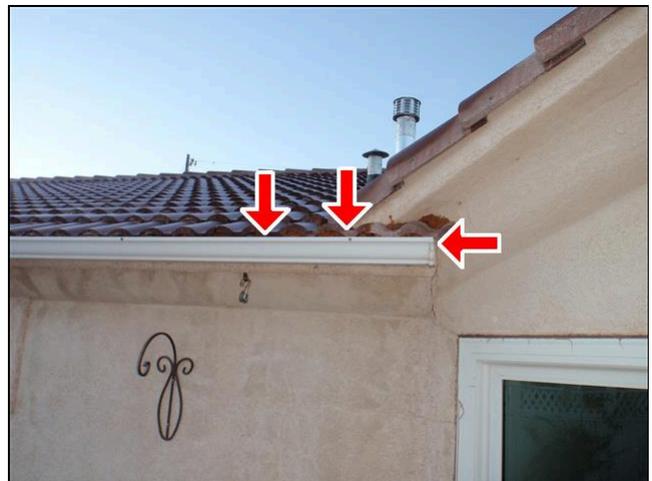
1.1 Item 2(Picture)

Drip edge flashing missing at the rear patio area and spray foam has been used. Recommend repair, replace or correct by a licensed roofing contractor.

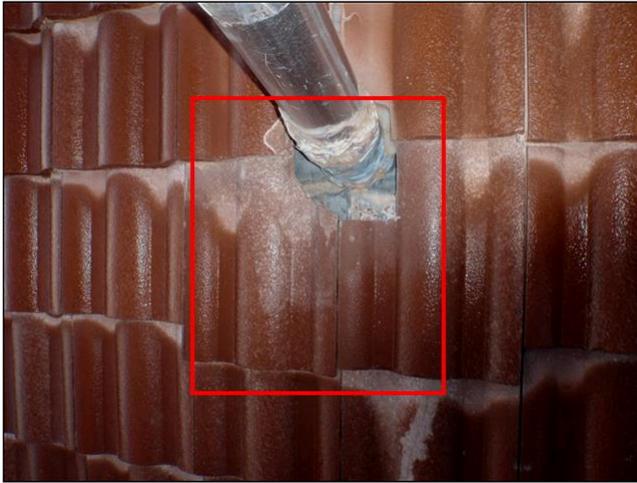
1.2 Item 1(Picture)

Water heater exhaust vent flashing not installed properly, underlayment damaged below concrete tiles. Recommend repair, replace or correct by a licensed roofing contractor.

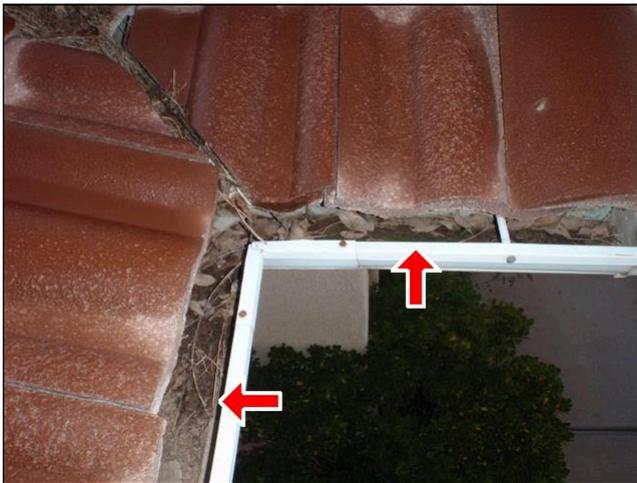
1.3 Item 1(Picture)

The rain gutters are full of debris in areas and need to be cleaned. Recommend cleaning rain gutters by a qualified person.

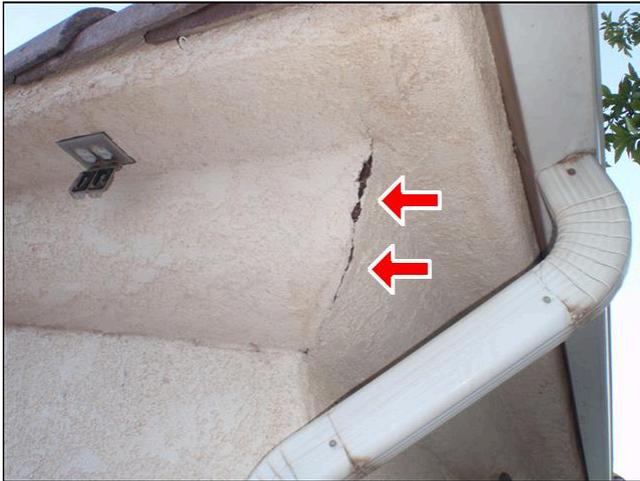
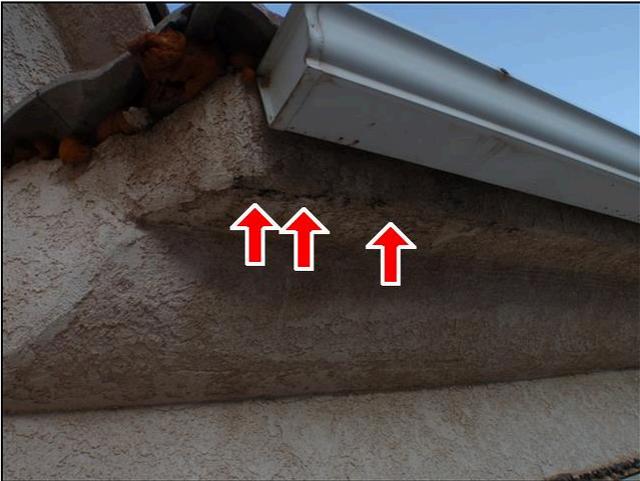
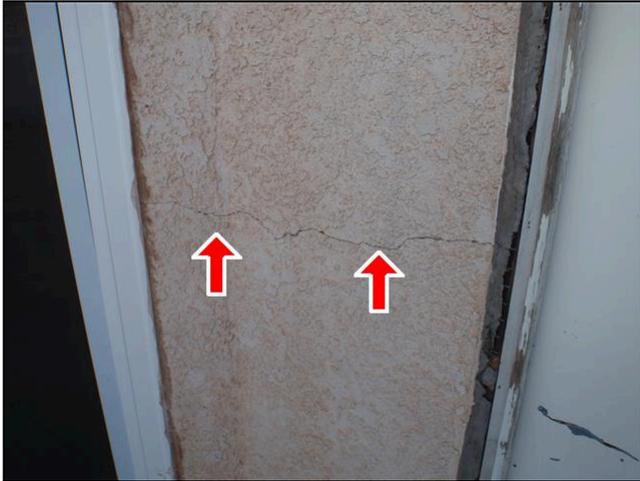
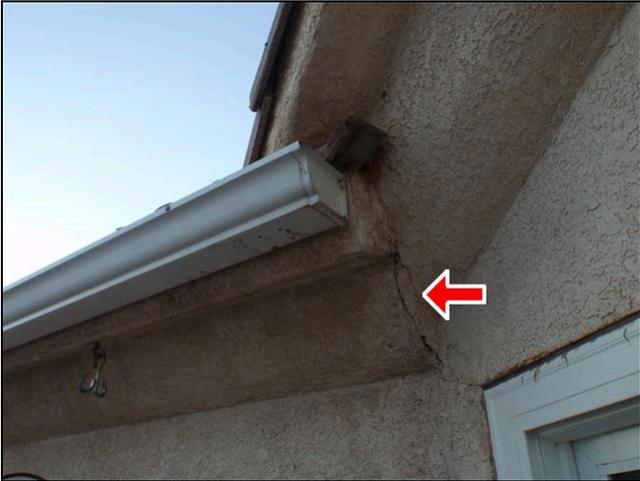
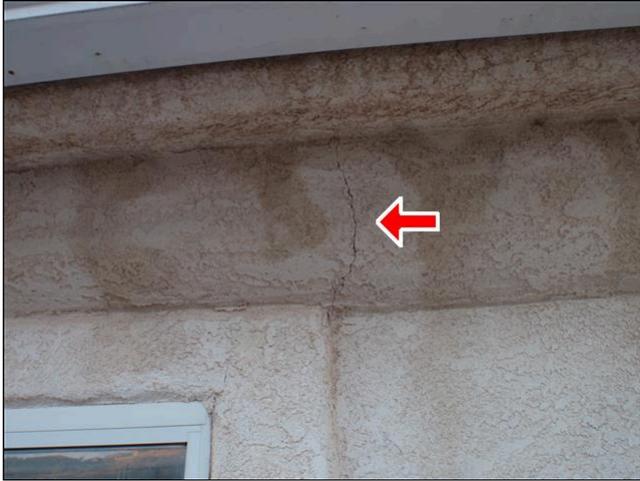
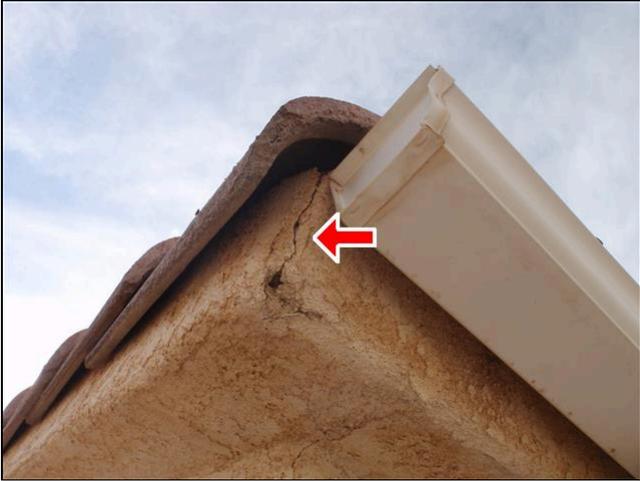
(1) Stucco damaged, (cracks and peeling as well as exposed lower styrofoam insulation around the whole house) appears to be from moisture. Recommend further evaluation by a licensed stucco contractor.

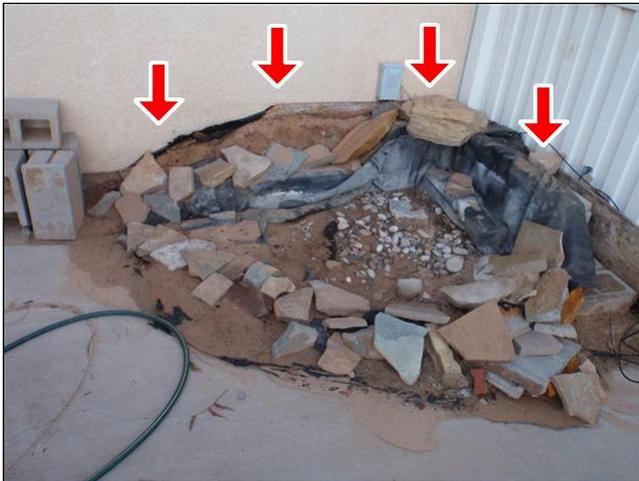
2.0 Item 14(Picture)

(2) Rear patio area, plastic and wood against the stucco is damaging the stucco siding (attracts wood rot and termites). Recommend repair or correct by a qualified person.

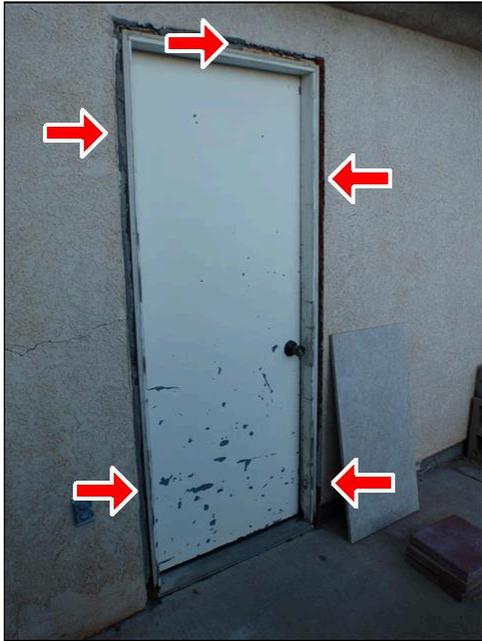
2.0 Item 15(Picture)

(3) Wood trim around garage outside occupant door is missing. Recommend repair, replace or correct by a qualified person.

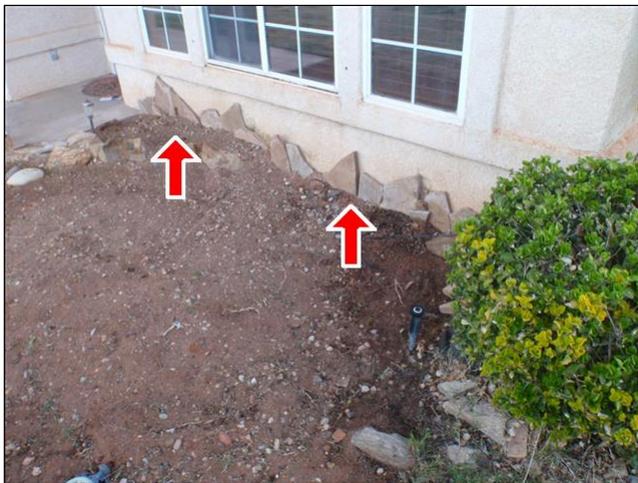
2.0 Item 16(Picture)

(4) Front area, soil and rock against the stucco is damaging the stucco siding (attracts wood rot and termites). Recommend repair or correct by a qualified person to prevent moisture and insect intrusion.

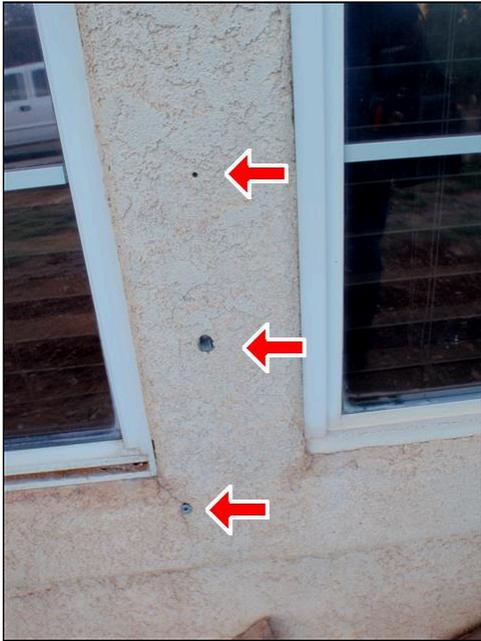
2.0 Item 17(Picture)

(5) Holes in stucco (front of home). Recommend seal holes with caulking by a qualified person to prevent moisture and insect intrusion.

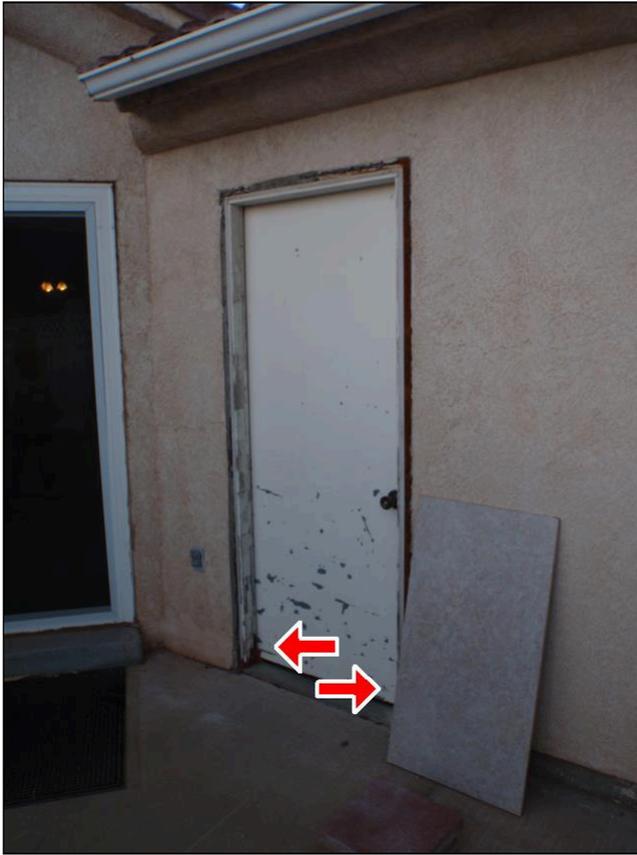
2.1 Item 1(Picture)

(1) Rear garage occupant door, wood rot at lower door jamb. Recommend repair, replace or correct by a licensed building contractor.

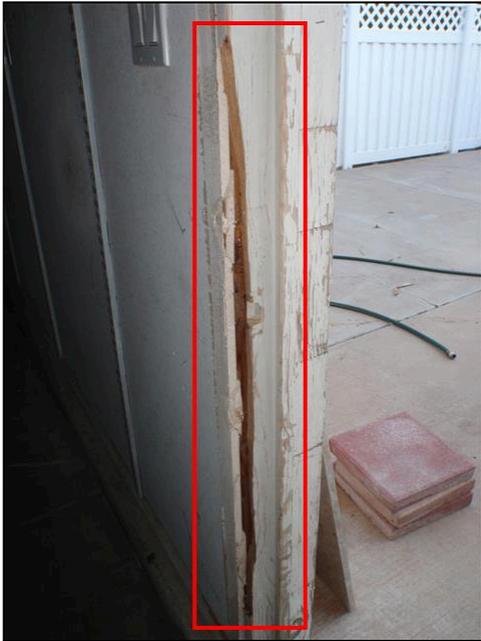
2.1 Item 4(Picture)

(2) Rear garage occupant door jamb damaged and missing striker plate, door will not stay secured and will not lock. Recommend repair, replace or correct by a licensed building contractor.

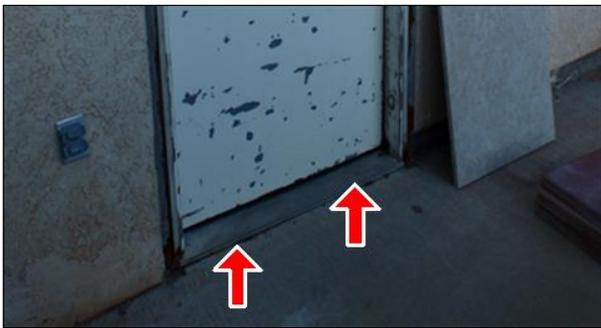
2.1 Item 5(Picture)

(3) Garage rear occupant door threshold appears to be loose. Recommend repair, replace or correct by a qualified person.

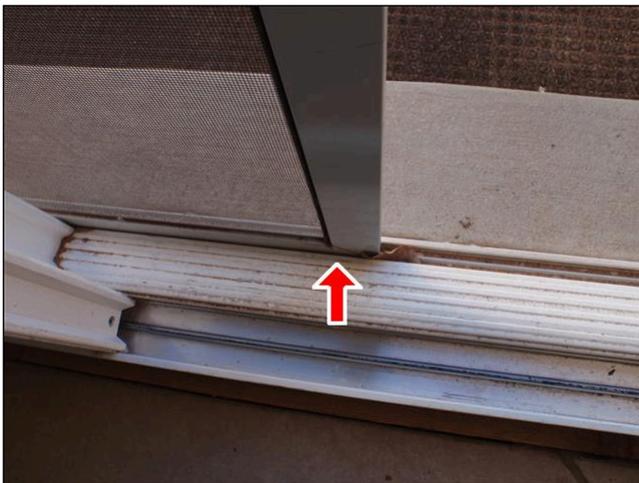
2.1 Item 6(Picture)

(4) Rear sliding screen door is very hard to slide open and close (rollers damaged). Recommend repair or correct by a qualified person.

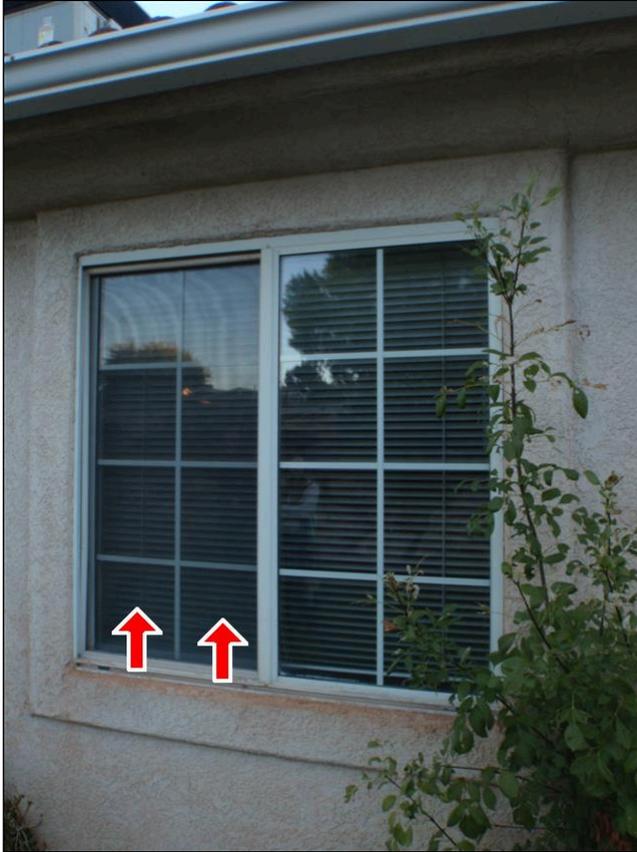
2.2 Item 1(Picture)

(1) Rear corner guest bedroom window pane is broken. Recommend repair, replace or correct by a licensed window contractor.

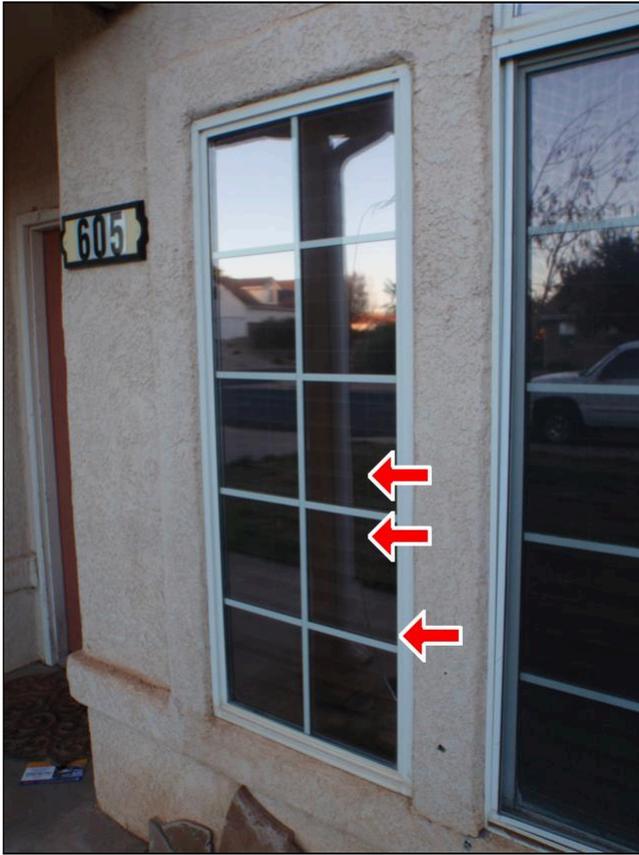
2.2 Item 2(Picture)

(2) Front living area window pane is broken. Recommend repair, replace or correct by a licensed window contractor.

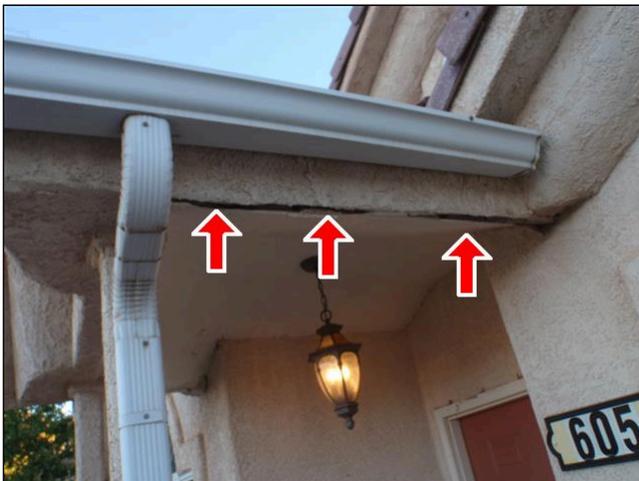
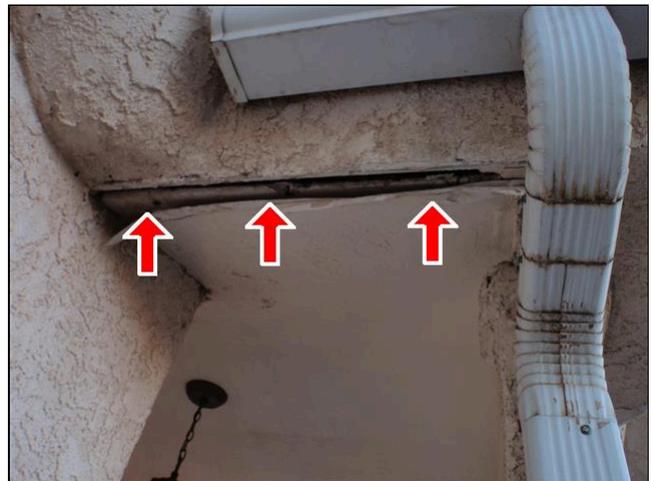
2.3 Item 1(Picture)

Front entry way ceiling damaged where it meets the stucco. Recommend repair, replace or correct by a licensed building contractor.

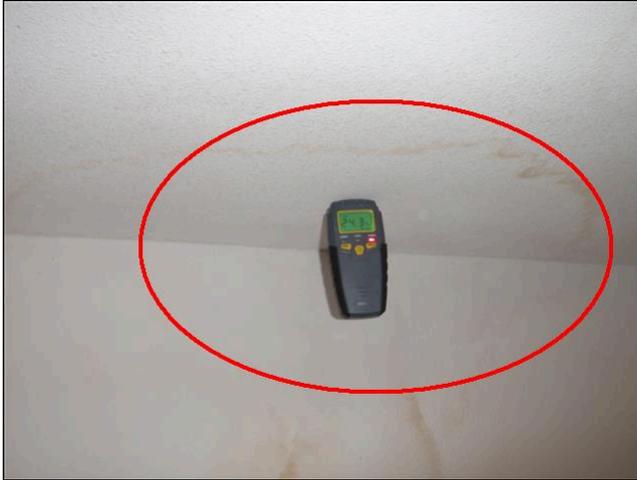
3.0 Item 1(Picture)

Garage ceiling shows signs of moisture/roof leak (above rear occupant door), wet at time of inspection. Recommend repair, replace or correct after roof leak is repaired by a licensed building contractor.

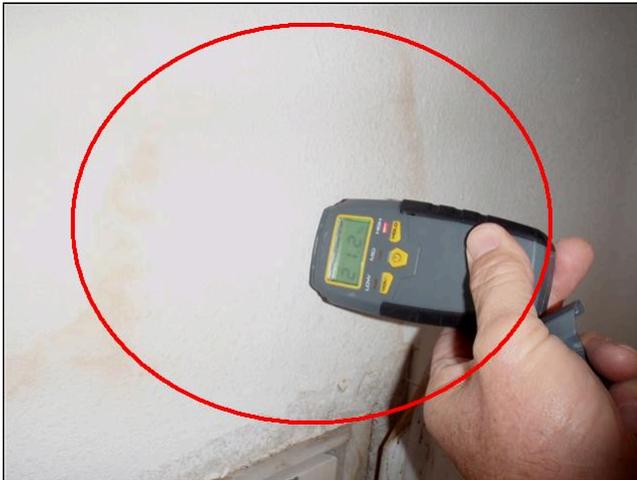
3.1 Item 1(Picture)

Garage wall shows signs of moisture/roof leak (above rear occupant door), wet at time of inspection. Recommend repair, replace or correct after roof leak is repaired by a licensed building contractor.

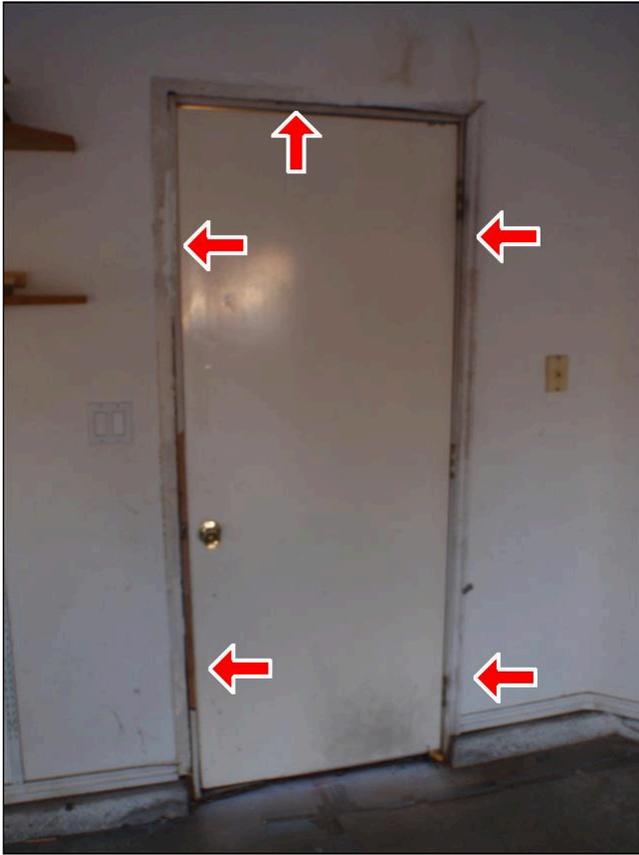
3.4 Item 1(Picture)

Garage rear occupant door trim is missing. Recommend repair, replace or correct by a qualified person.

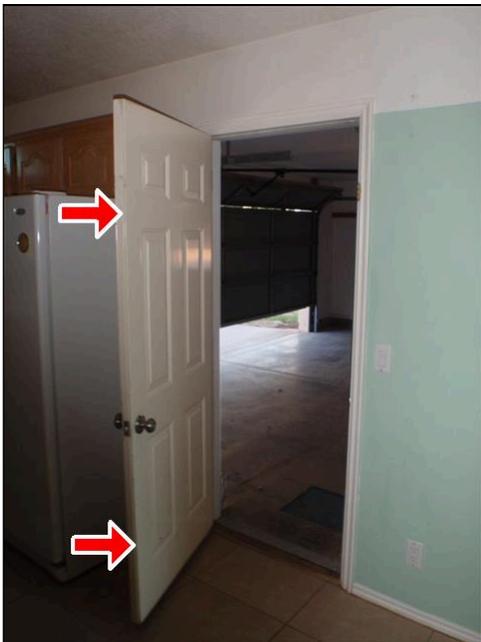
3.5 Item 1(Picture)

The occupant door from the attached garage to the inside of the house does not self close, the self closing spring hinge is missing or not functional. The purpose is to keep a garage fire from spreading to the house. Recommend repair, replace or correct by a qualified tradesman.
