Inspection Report

Sample Report

Property Address:
5741 Sample Property Drive
Washington UT 84780

Blue Majestic Home Inspections LLC

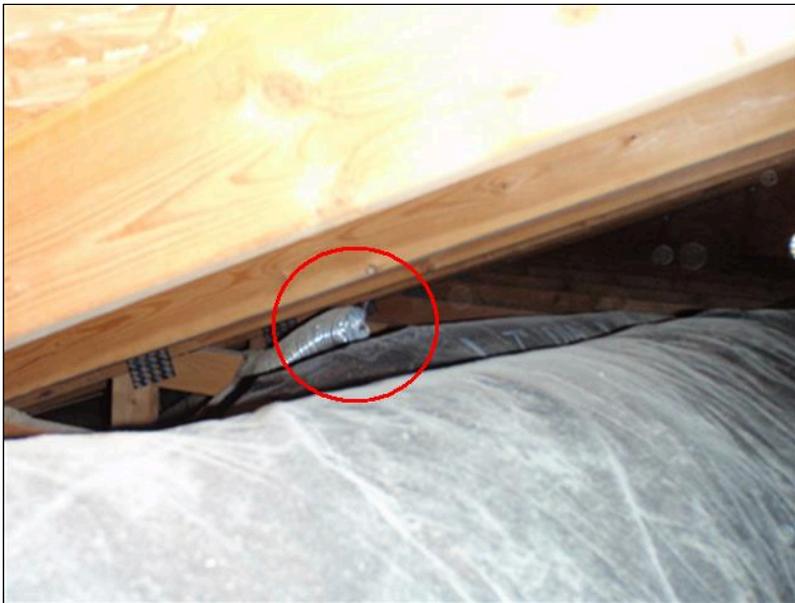
5.2 Item 1(Picture)

The bathroom exhaust fans are venting into the attic. Vent pipes that terminate in attic space can sometimes cause moisture that can lead to mold or cause condensation. A qualified contractor should inspect and repair as needed.

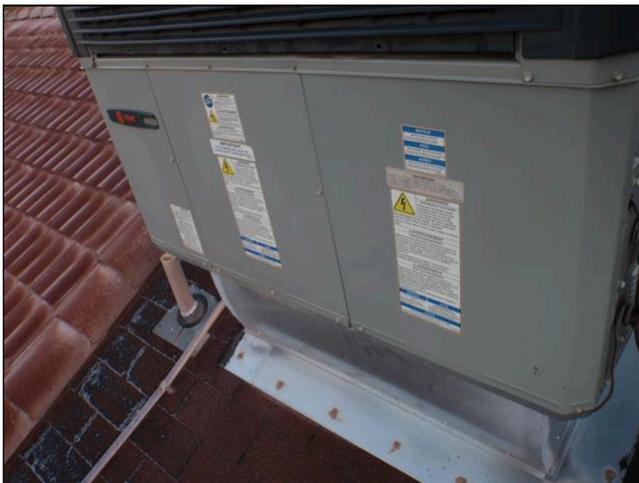
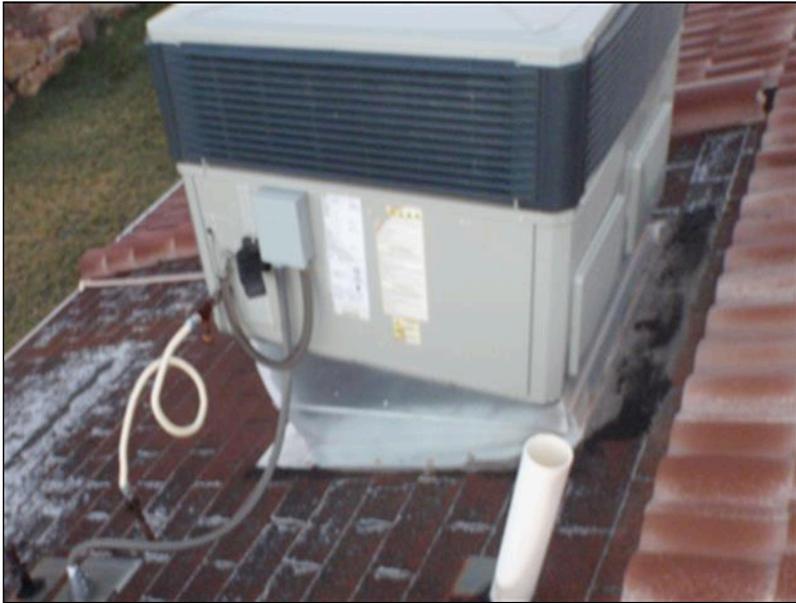
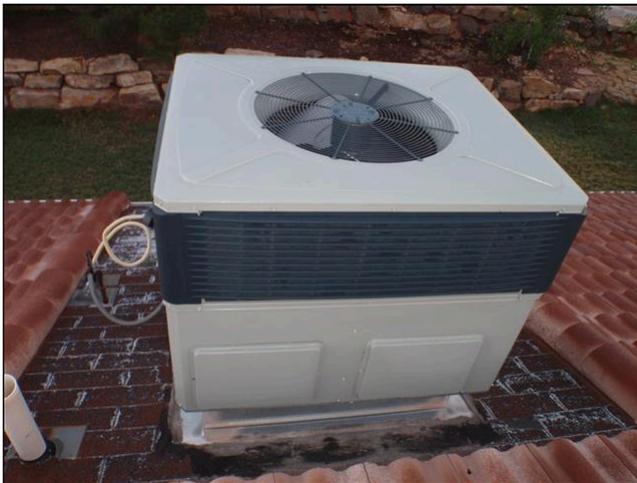
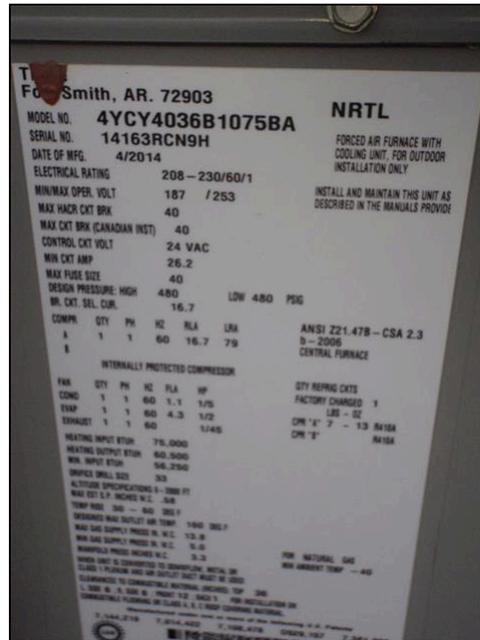
6.7 Item 2(Picture)

(2) The combination HVAC system appears to be functioning at time of inspection. Combination unit manufactures date is the 16th week of 2014.

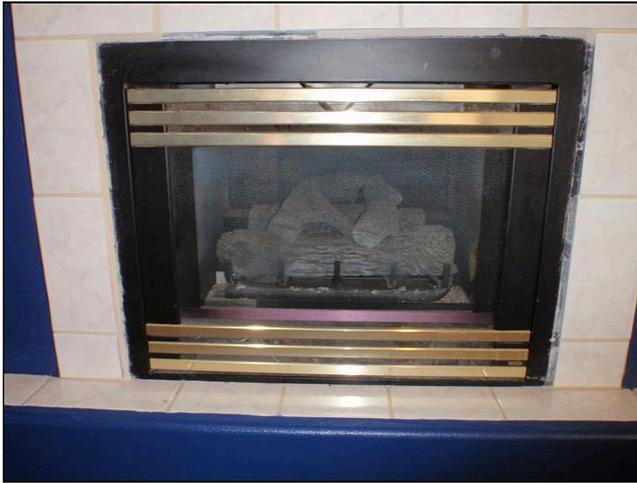
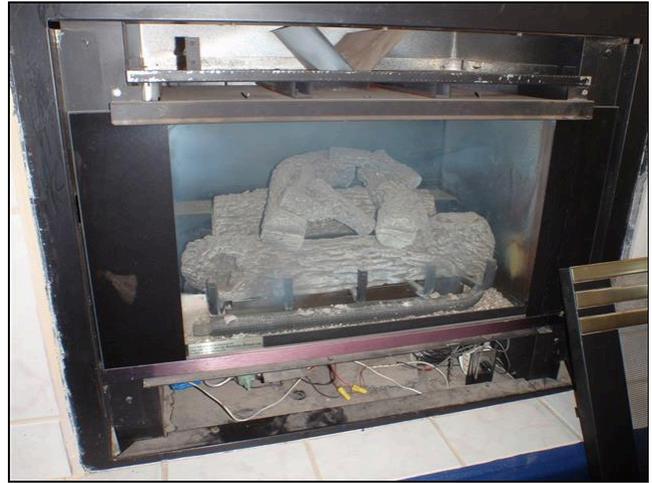
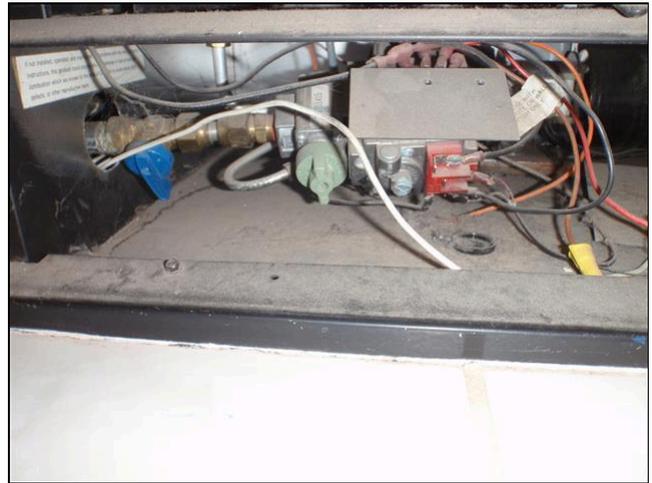
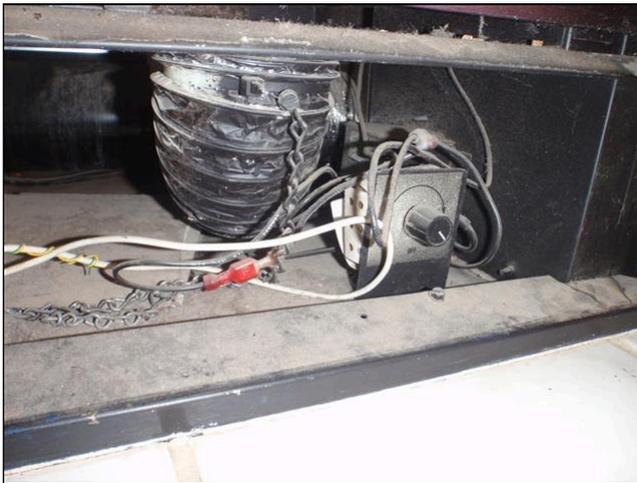
6.9 Item 1(Picture)

Natural gas fireplace unit appears to be functioning at the time of inspection, although very dirty and the fireplace wall switch did not function. Recommend natural gas fireplace unit be serviced by a licensed natural gas fireplace contractor.

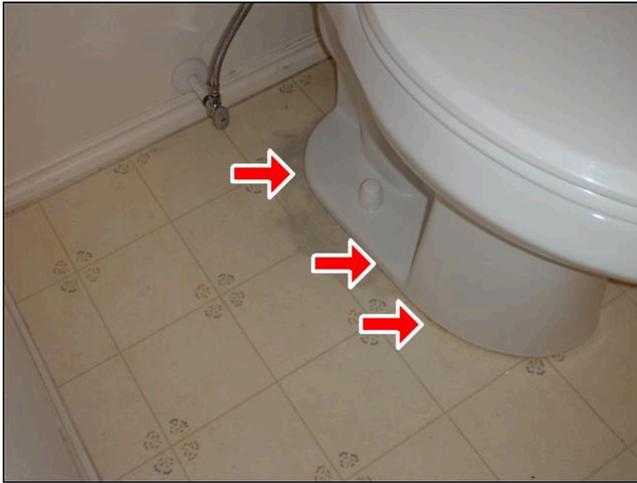
7.0 Item 1(Picture)

(1) Master bathroom toilet is loose from the floor. Repairs may involve re-setting the toilet on a new

wax seal. Recommend repair or correct by a licensed plumbing contractor.

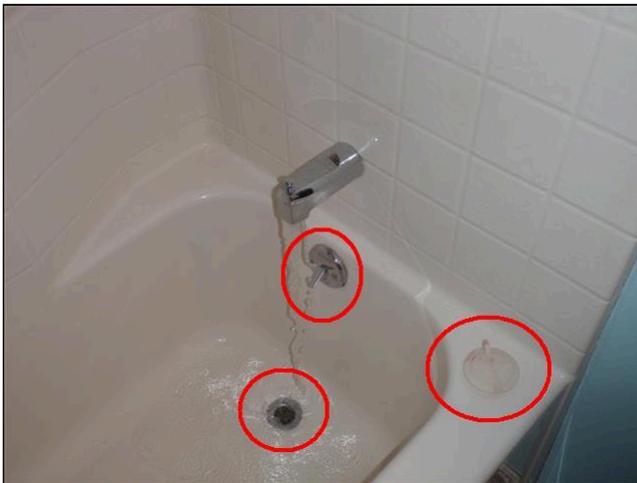
7.0 Item 2(Picture)

(2) Guest bathroom bath tub plunger does not function. Recommend repair, replace or correct by licensed plumbing contractor.

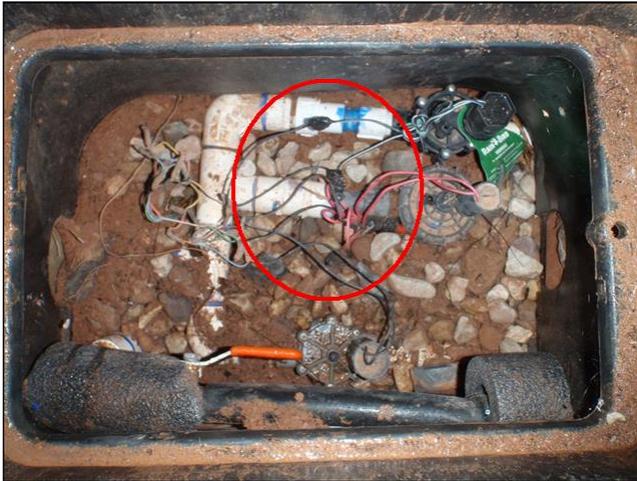
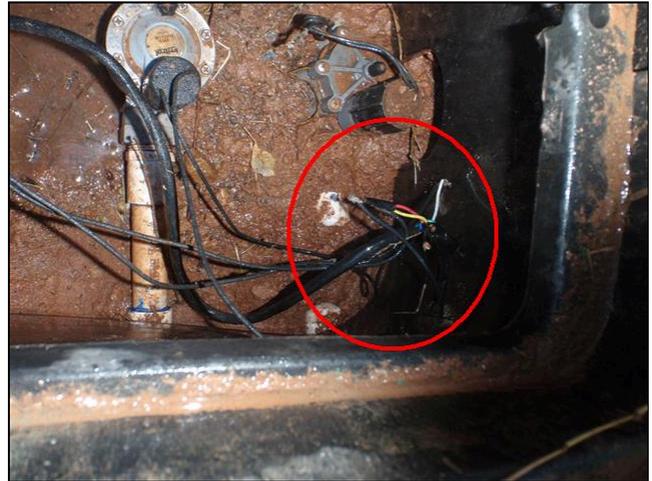
7.6 Item 1(Picture)

Sprinkler valve wires should be connected with moisture resistant wire connectors. Recommend repair or correct by a qualified person.

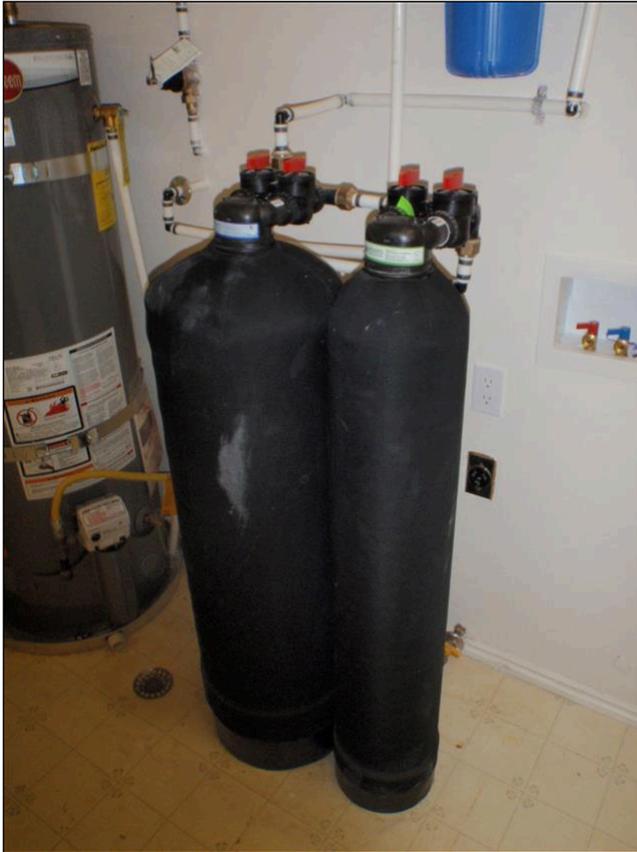
7.7 Item 1(Picture)

Water filtration system appears to be functioning at time of inspection, although we recommend having system serviced by a licensed plumbing contractor.

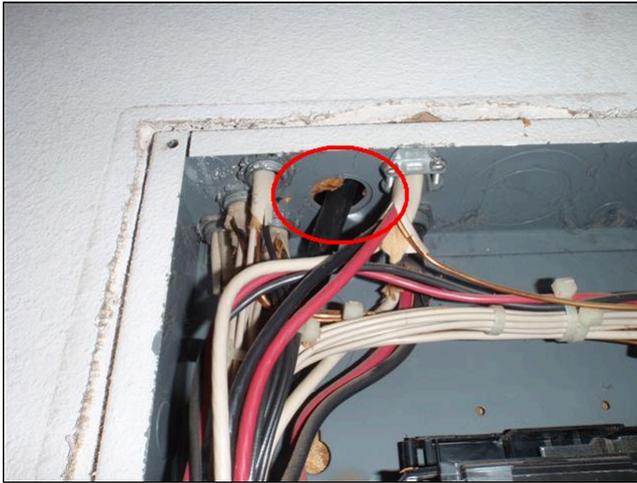
8.1 Item 1(Picture)

Circuit missing wire clamp in main electrical panel. Recommend repair, or correct by a licensed

electrical contractor.

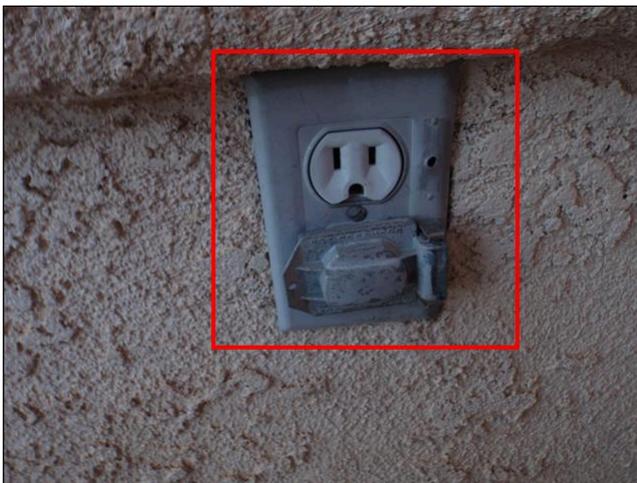
8.3 Item 1(Picture)

(1) Front entry area electrical outlet is missing weather resistant cover. Recommend replacing cover by a qualified person.

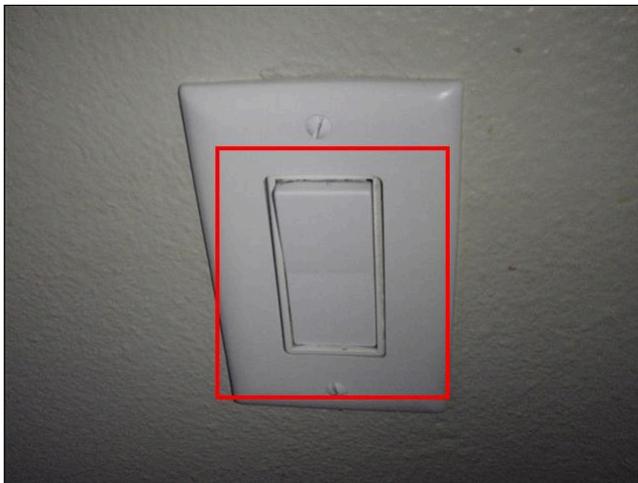
8.3 Item 3(Picture)

(3) Rear corner guest bedroom light switch is warped. Heat can cause them to warp. Recommend repair, replace or correct by a licensed electrical contractor.

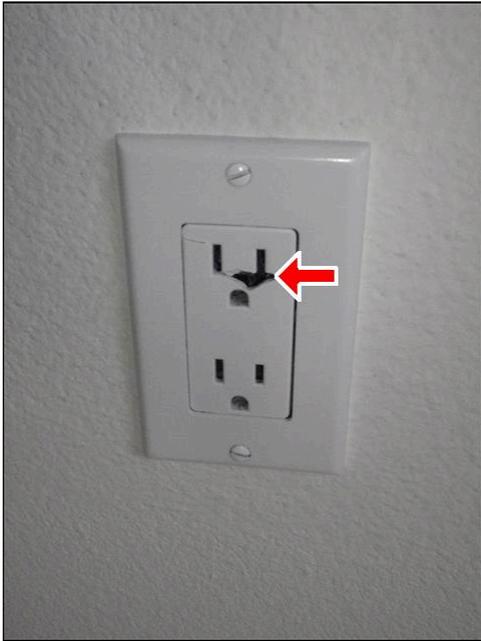
8.3 Item 4(Picture)

(4) West guest bedroom electrical outlet cracked. Recommend replace or correct by a licensed electrical contractor.

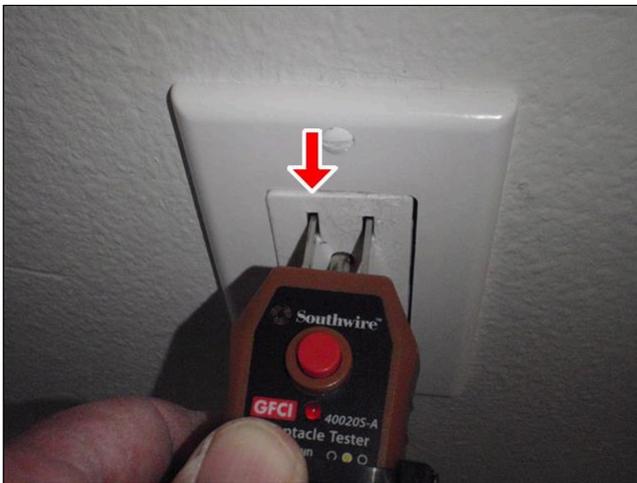
8.3 Item 5(Picture)

(5) Electrical outlet in dining area, can not insert plug. Recommend repair, replace or correct by a licensed electrical contractor.

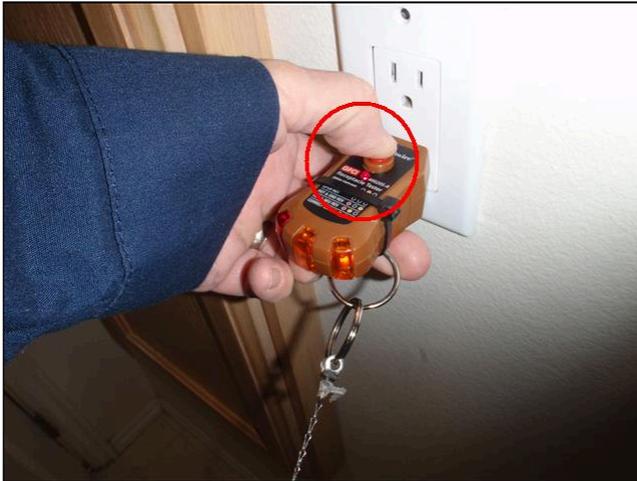
8.5 Item 1(Picture)

(1) Laundry room electrical outlets are not GFCI protected. Recommend installing GFCI receptacles for safety by a licensed electrician.

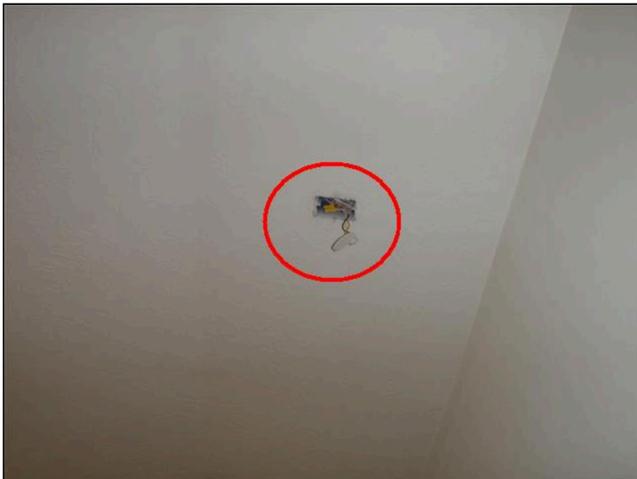
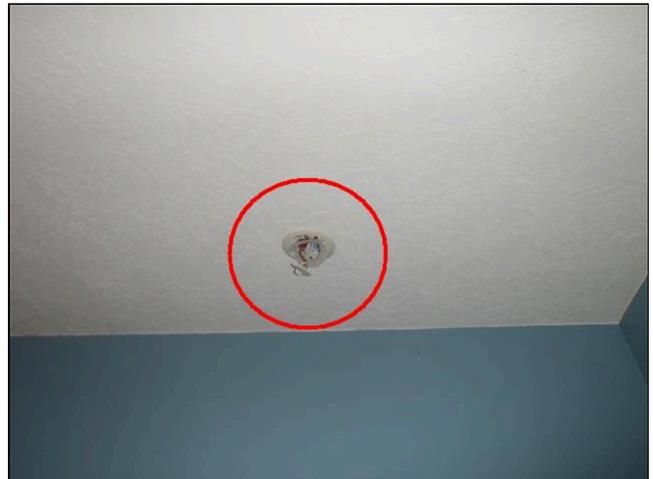
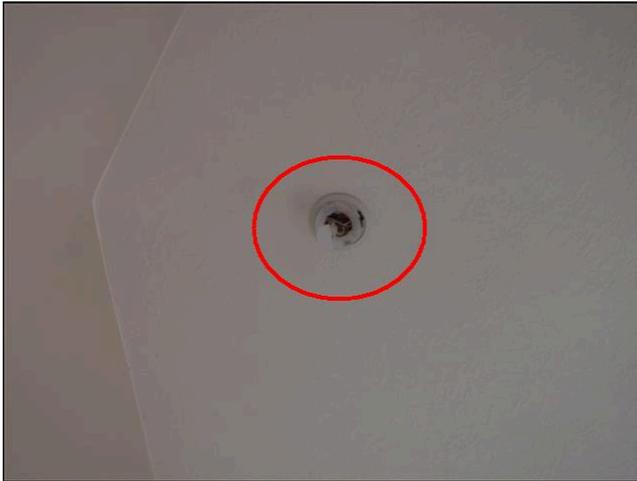
8.7 Item 1(Picture)

(1) All three bedrooms missing smoke detectors. Recommend installing smoke detectors by a qualified person.

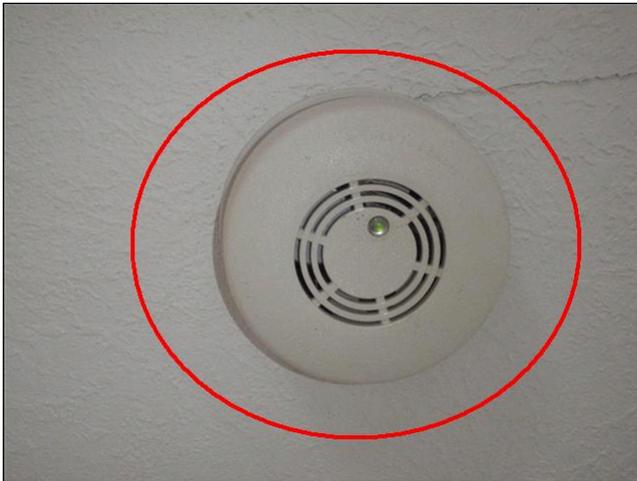
8.7 Item 4(Picture)

(2) The hallway smoke detector is old and its color has changed. Recommend replace smoke detector as per manufacturers instructions.

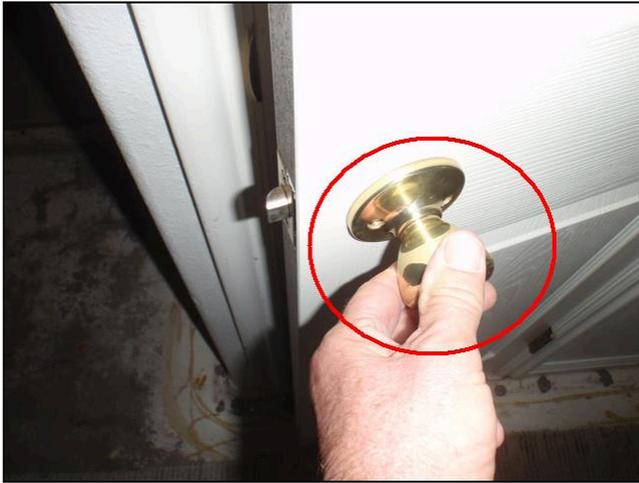
9.3 Item 1(Picture)

Hallway closet door knob hard to turn. Recommend repair, replace or correct by a qualified person.

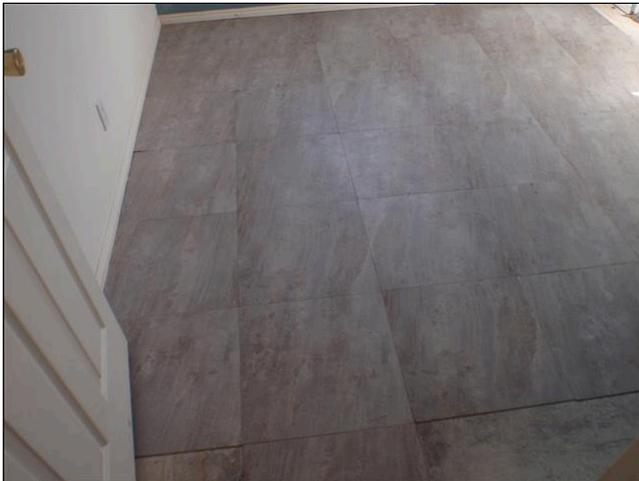
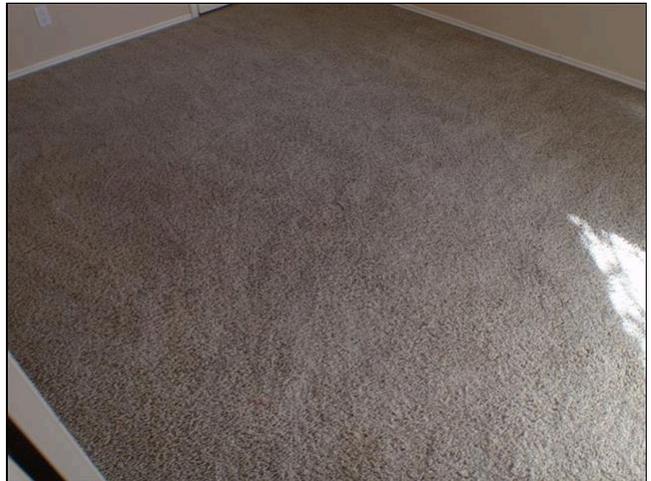
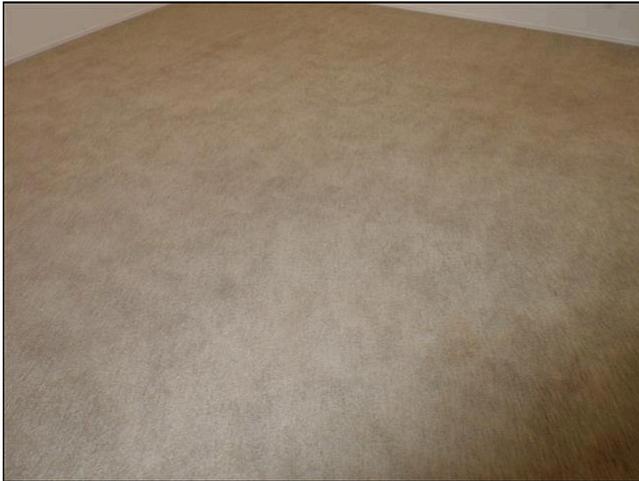
10.2 Item 1(Picture)

All interior flooring is old, damaged or missing. Recommend repair, replace or correct by a licensed flooring contractor.

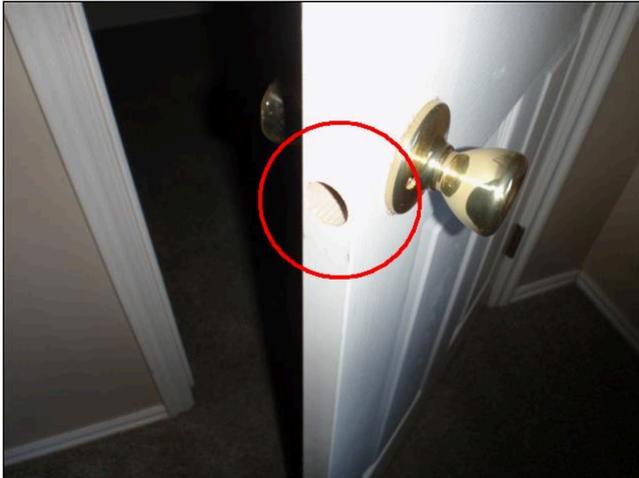
10.3 Item 1(Picture)

(1) Rear corner bedroom closet door latch missing. Recommend replace or correct by a qualified person.

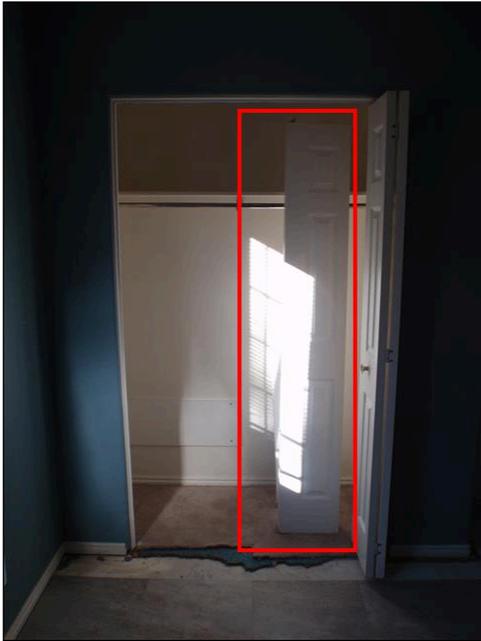
10.3 Item 2(Picture)

(2) Middle bedroom closet door not in place. Recommend repair, replace or correct by a qualified person.

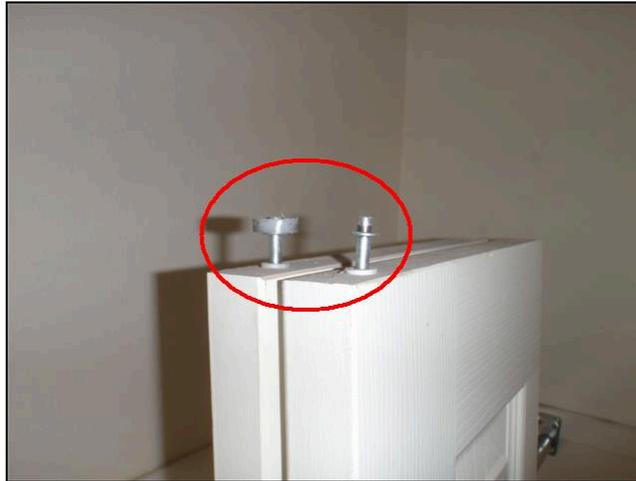
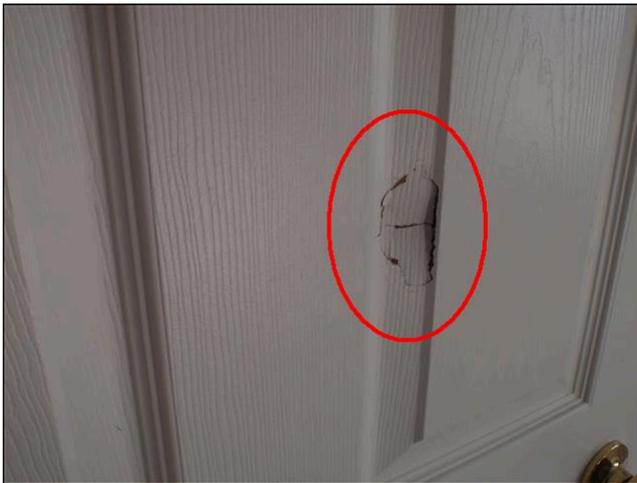
10.3 Item 3(Picture)

(3) Middle guest bedroom door has a hole in it. Recommend repair or correct by a qualified person.

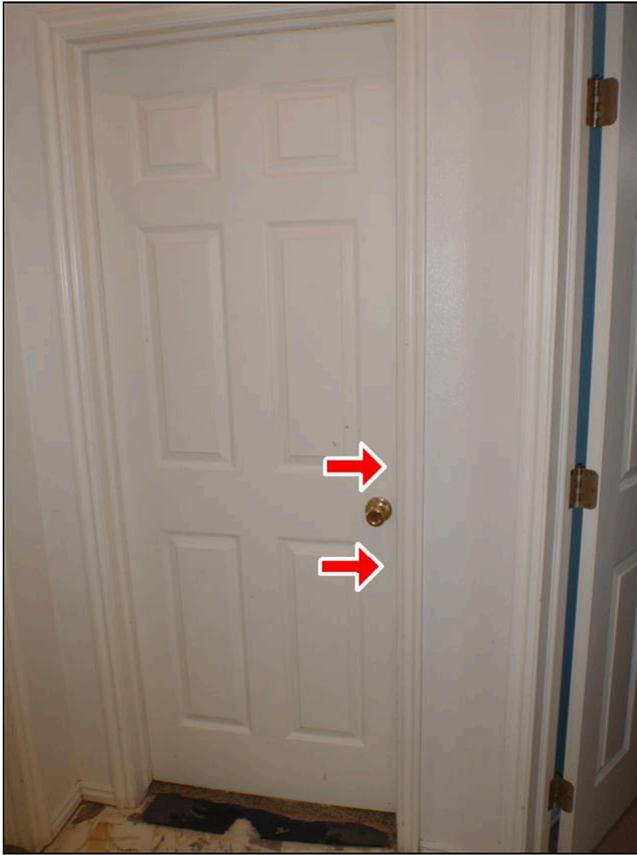
10.3 Item 5(Picture)

(4) Rear corner bedroom door hitting door jamb. Recommend repair or correct by a qualified person.

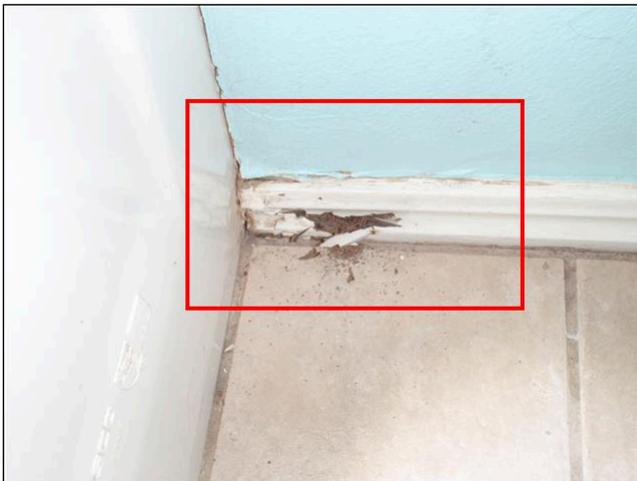
11.1 Item 1(Picture)

Guest bathroom lower wall trim shows sign of wood rot as well as termite intrusion. Recommend repair or correct by a licensed pest control and building contractor.

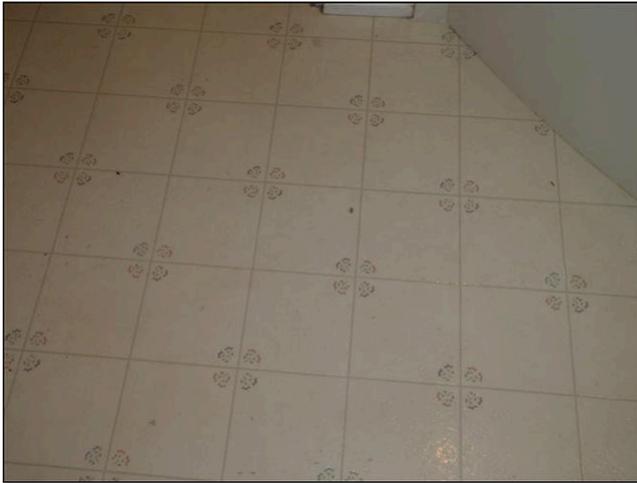
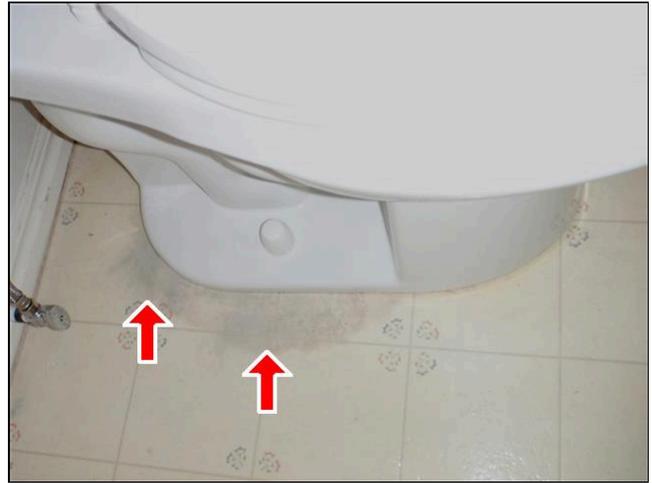
Master bathroom vinyl floor shows signs of wear, chips and stains in areas. Recommend repair, replace

or correct by a licensed flooring contractor.

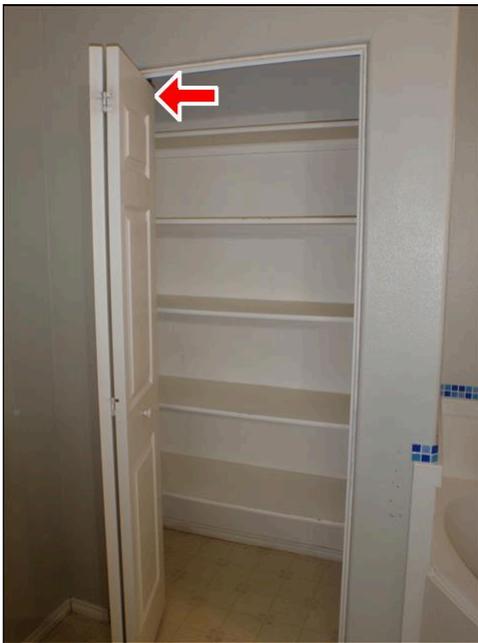
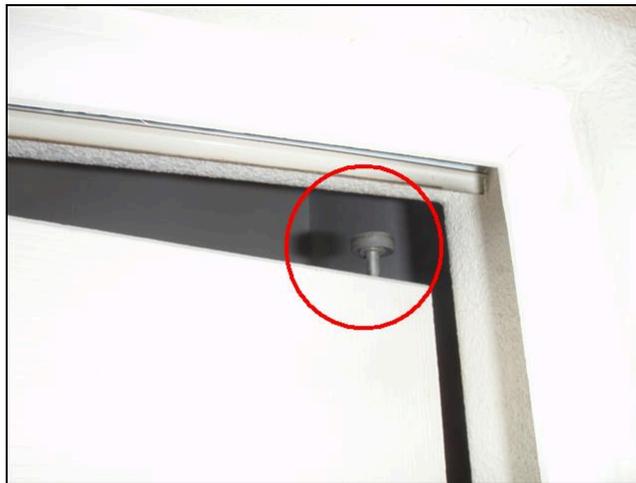
Master bathroom closet door upper roller does not stay in track. Recommend repair, replace or correct by a qualified person.

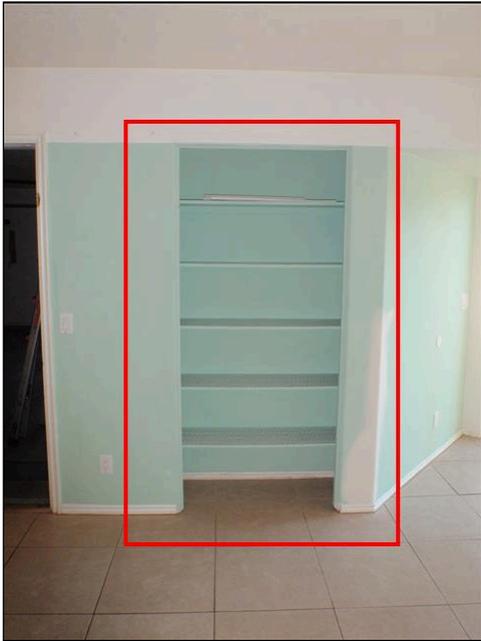
12.4 Item 1(Picture)

Kitchen pantry doors are missing. Recommend replacing doors by a licensed door contractor.

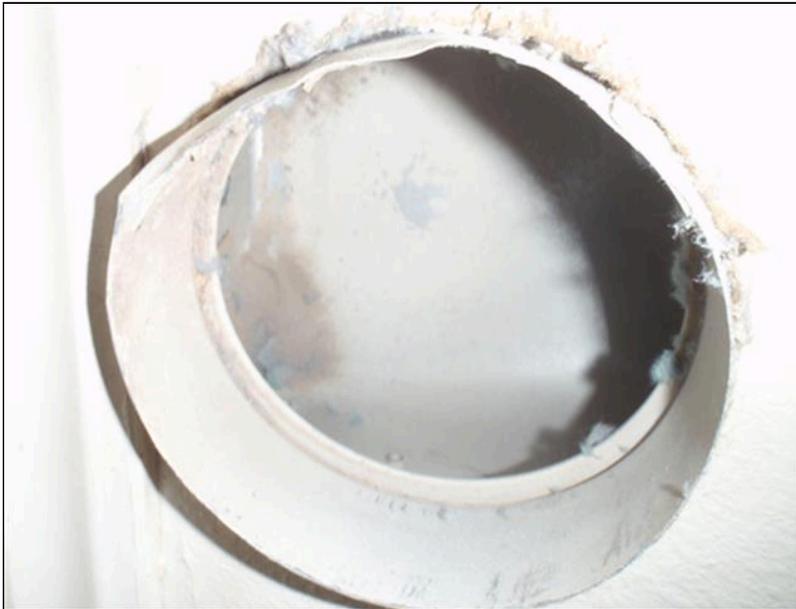
13.0 Item 1(Picture)

The dryer vent duct has a build-up of lint. Recommend cleaning dryer vent pipe by a qualified person.

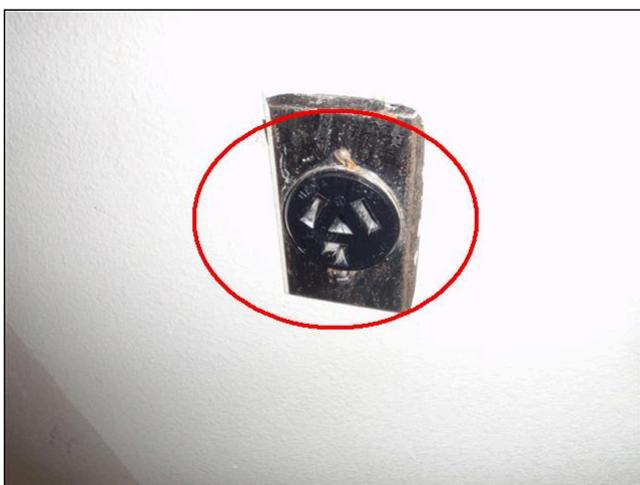
13.2 Item 1(Picture)

The dryer 220 electrical outlet appears to be the three prong type. Recommend upgrading to the newer four prong electrical outlet for newer dryers by a licensed electrical contractor.

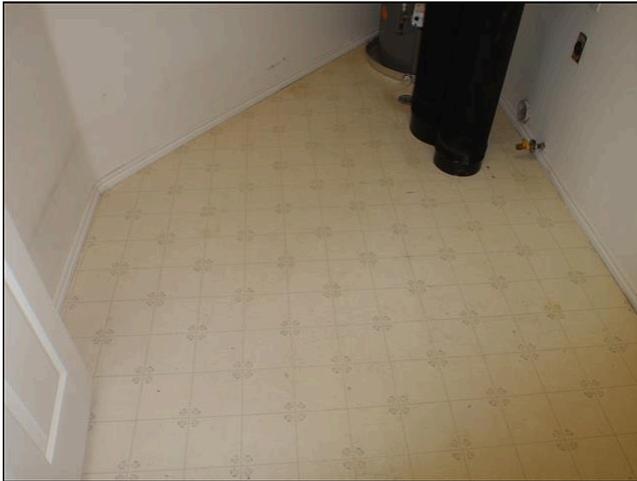
13.6 Item 1(Picture)

Laundry room flooring is old and damaged. Recommend repair, replace or correct by a licensed flooring contractor.

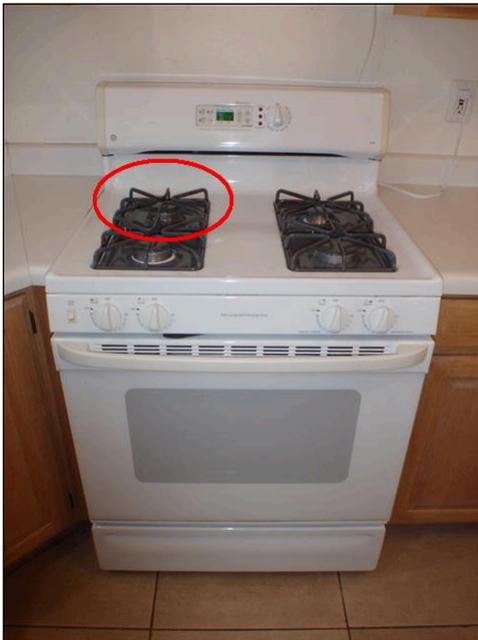
14.1 Item 1(Picture)

(1) The stove left rear top burner does not light. Recommend repair, replace or correct by a licensed appliance contractor.

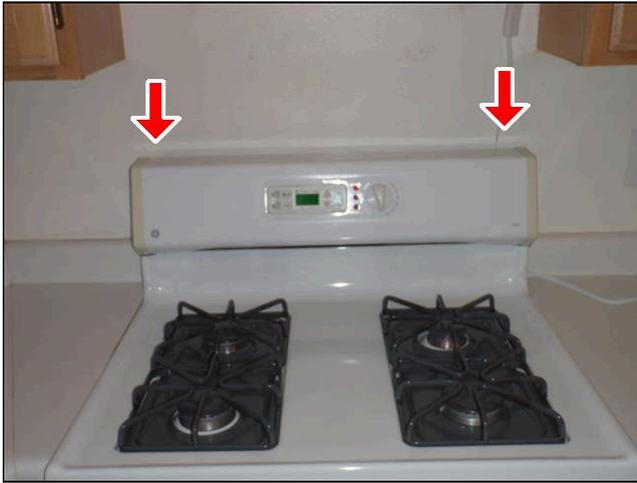
14.1 Item 3(Picture)

(2) Range Anti Tip Bracket is not installed on freestanding, slide in or drop in range. Recommend installing Anti Tip Bracket by a qualified person for safety.

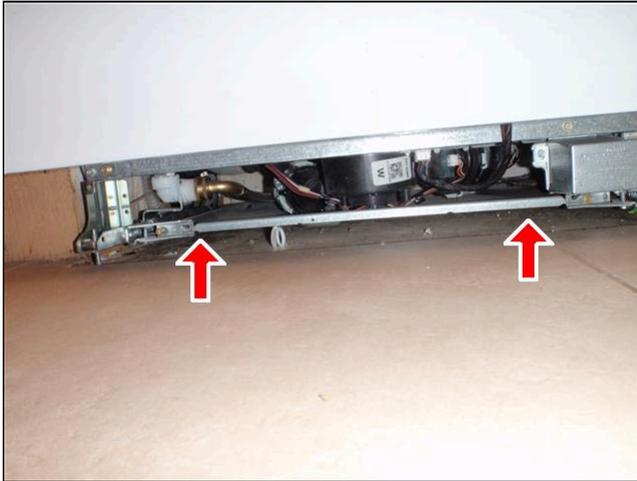
14.2 Item 1(Picture)

(1) Dishwasher lower front panel missing. Recommend replace or correct by a qualified person.

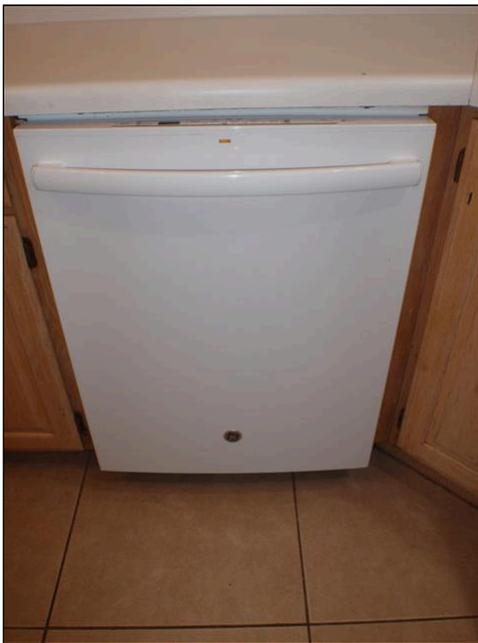
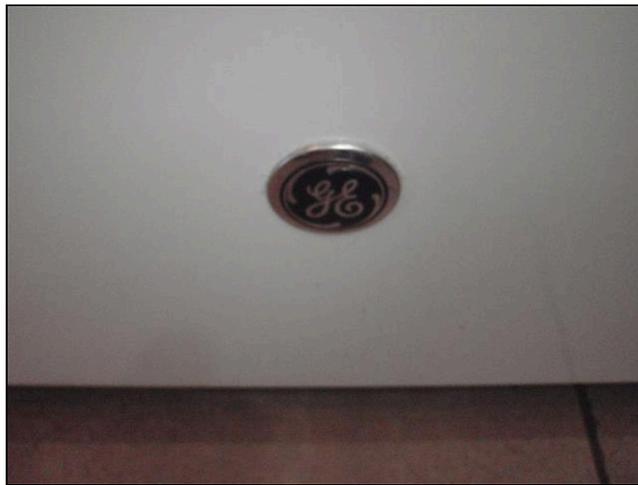
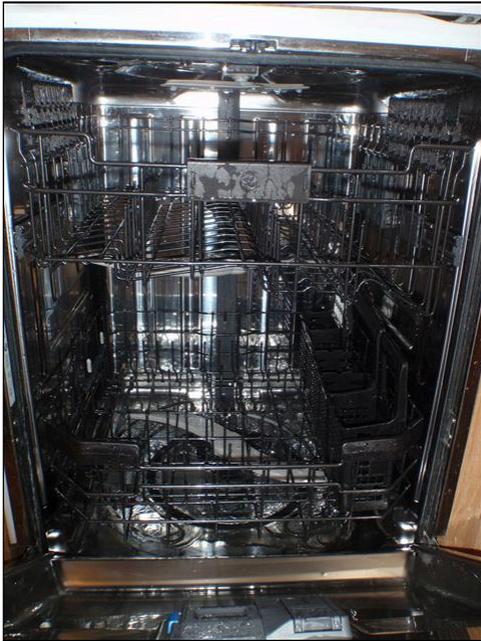
(3) The dishwasher appears to be functioning at the time of the inspection.
